FINAL REPORT

EVALUATION AND ASSESSMENT TROY ELEMENTARY SCHOOL 44 SCHOOL STREET TROY, NEW HAMPSHIRE

FOR
MONADNOCK SCHOOL DISTRICT
SAU #93, SWANZEY, NEW HAMPSHIRE
JUNE 30, 2017
The H.L. Turner Group Inc.

Facility Assessment

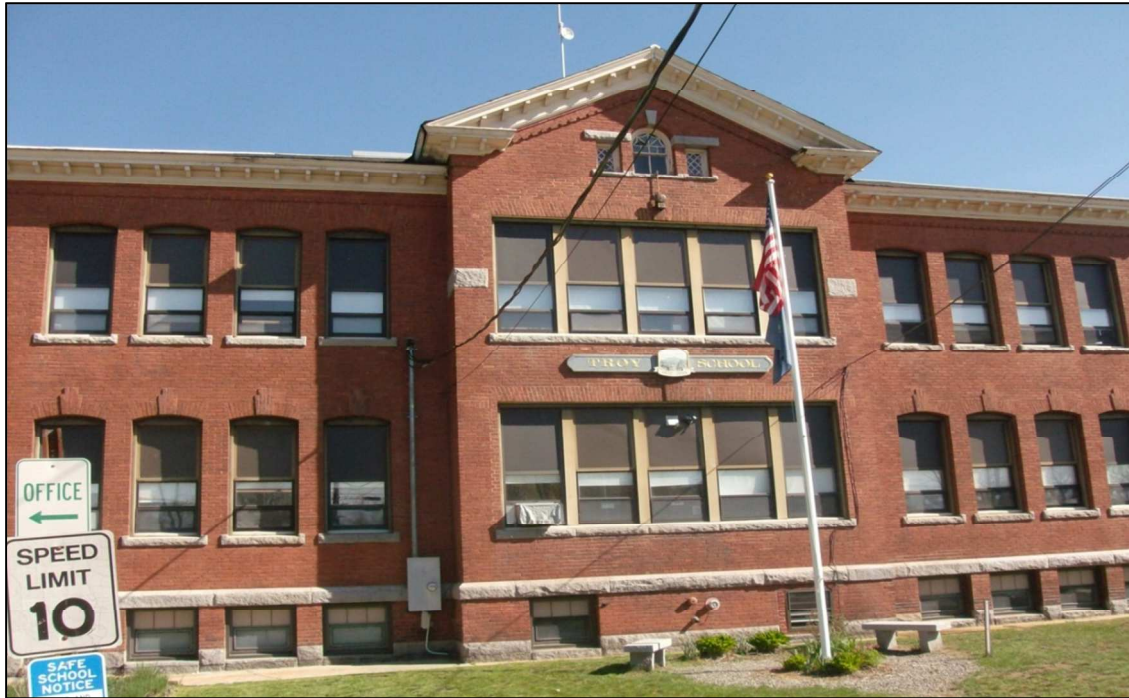
South side of original building. Furnace louver vent behind flagpole.

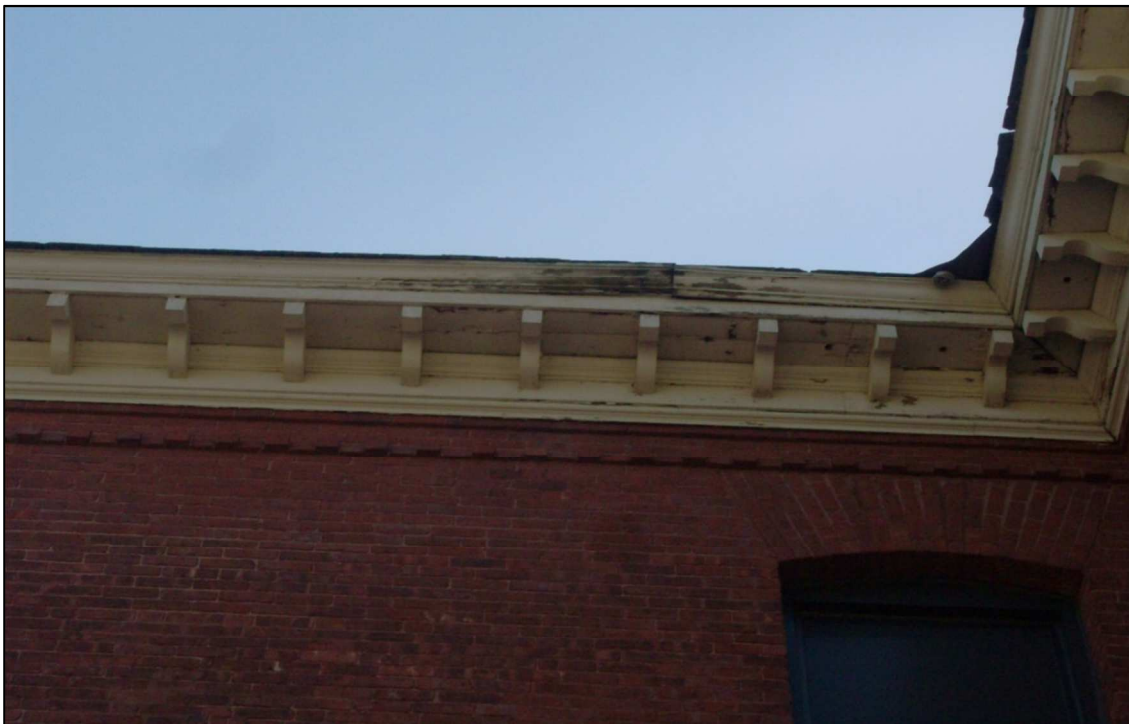
Many sections of the wood cornice and soffit millwork on the original building have badly peeling paint and some wood rot. Other areas of the school have similar conditions along the soffit trim. All the millwork should be scraped, painted, and replaced as needed where rot has occurred.

Section of rotted wood millwork at eave of original building.

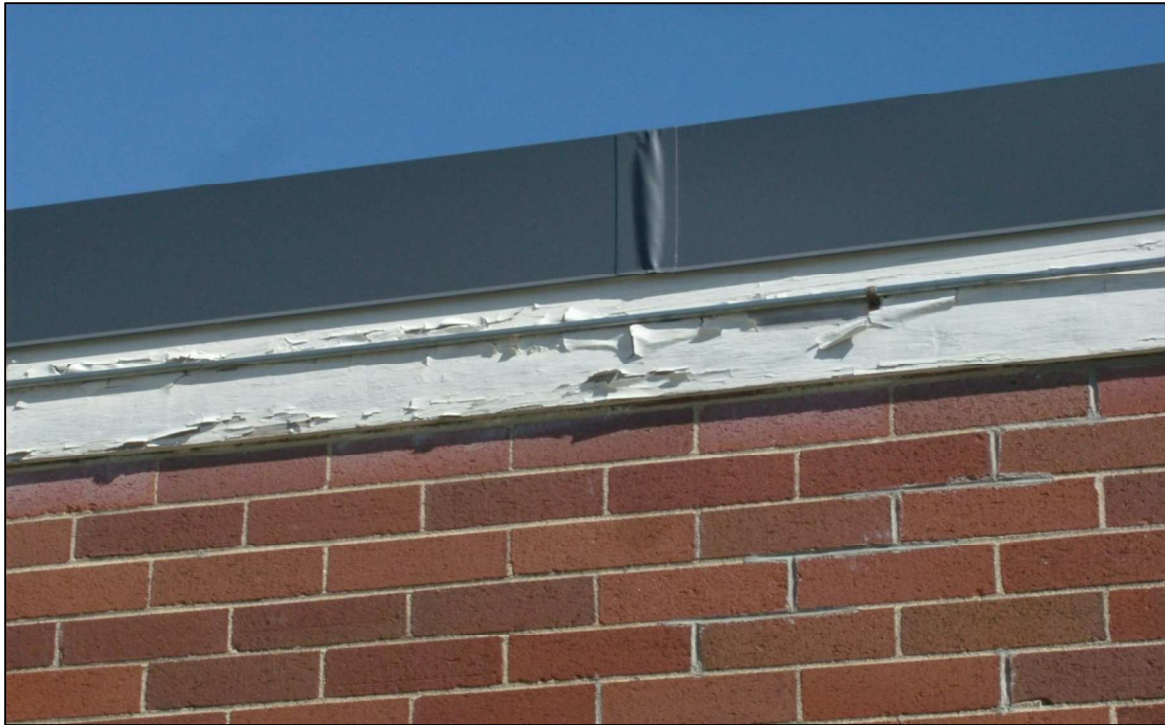
Peeling paint on wood trim at 70's addition.

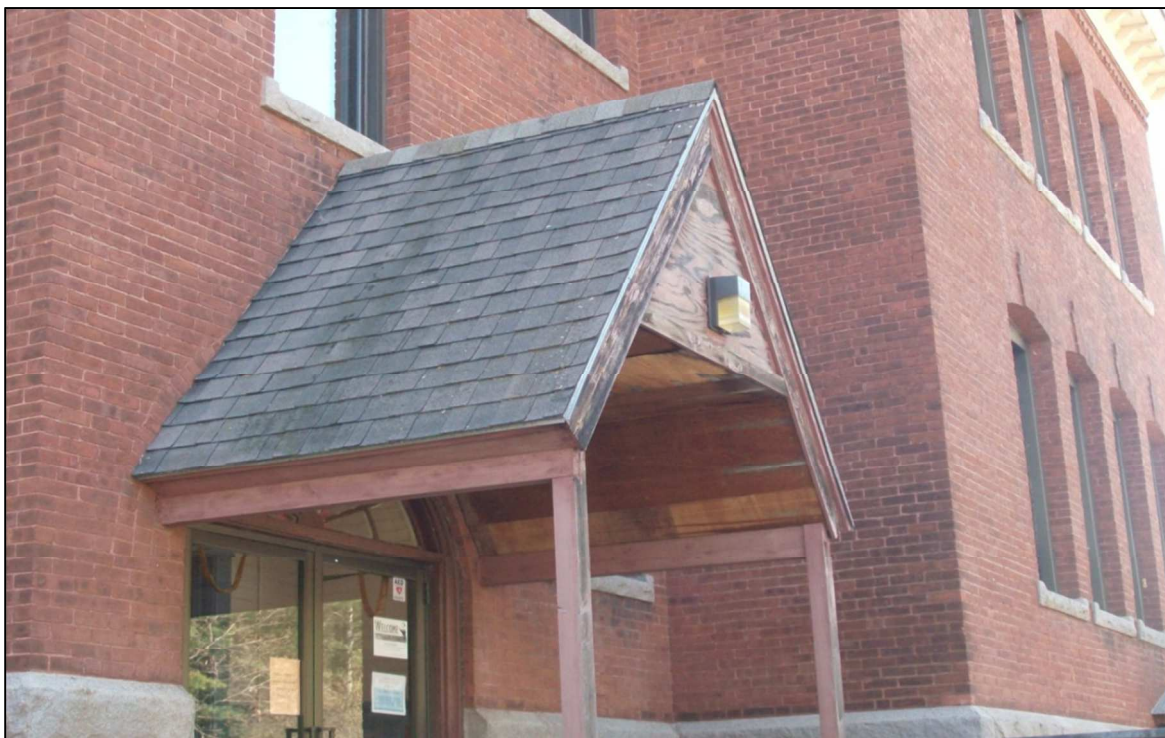
Wood framed canopy at entrance on west side.

- Rebuild the canopies over the entry doors. (\$30,000)

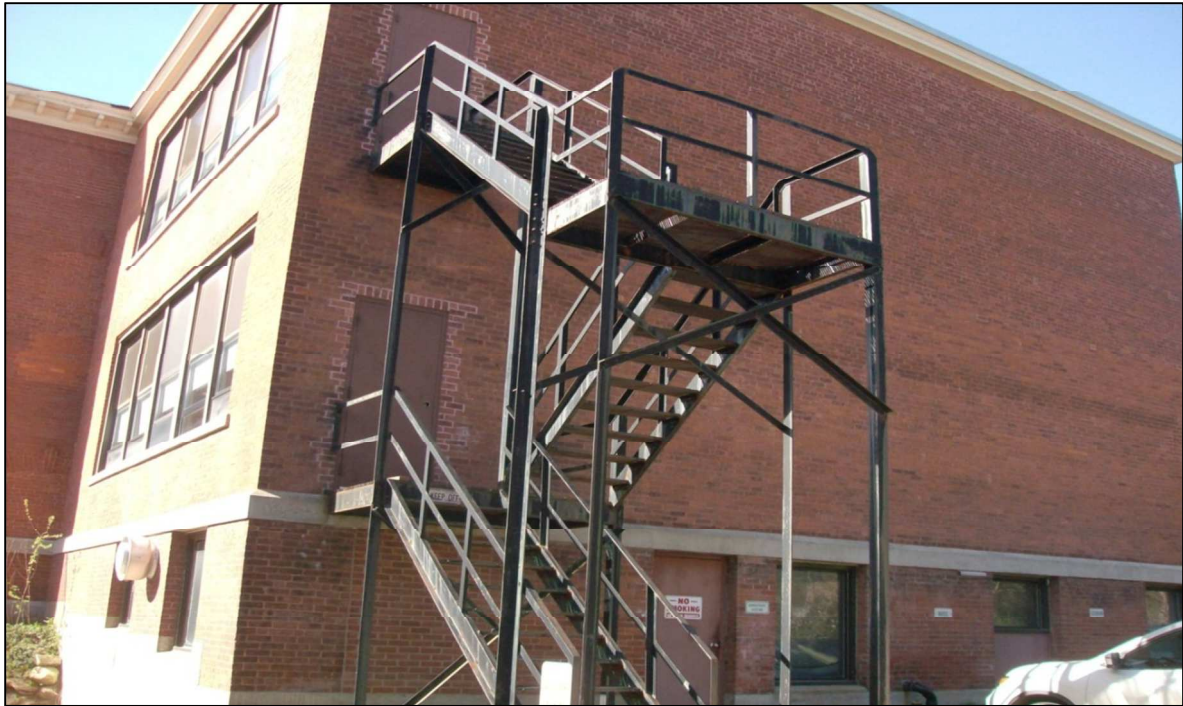
There are two steel fire escape structures; one on the east side of the 1895 section and one on the north side of the 1930's section. The fire escapes are in fair to poor condition. New updated stairs or should be considered. Fire codes should be reviewed as part of a redesign of the stairs.

Steel framed stairs on north side of original building.

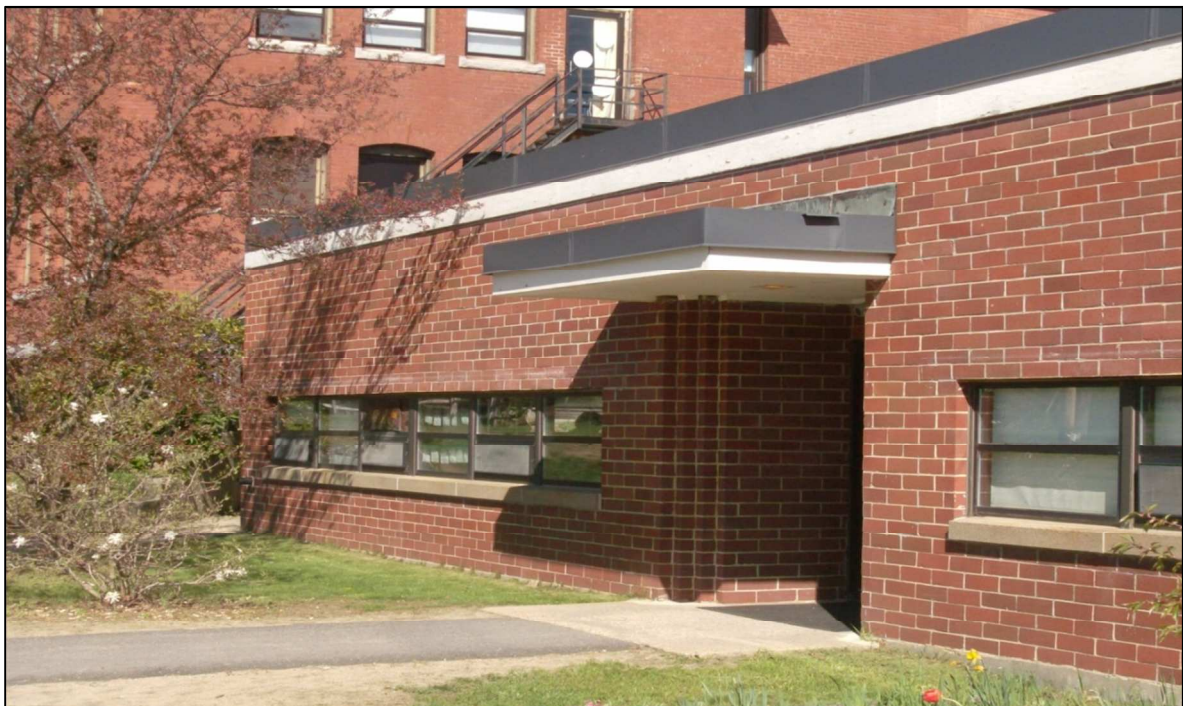
Only accessible entrance on south side of 70's addition.

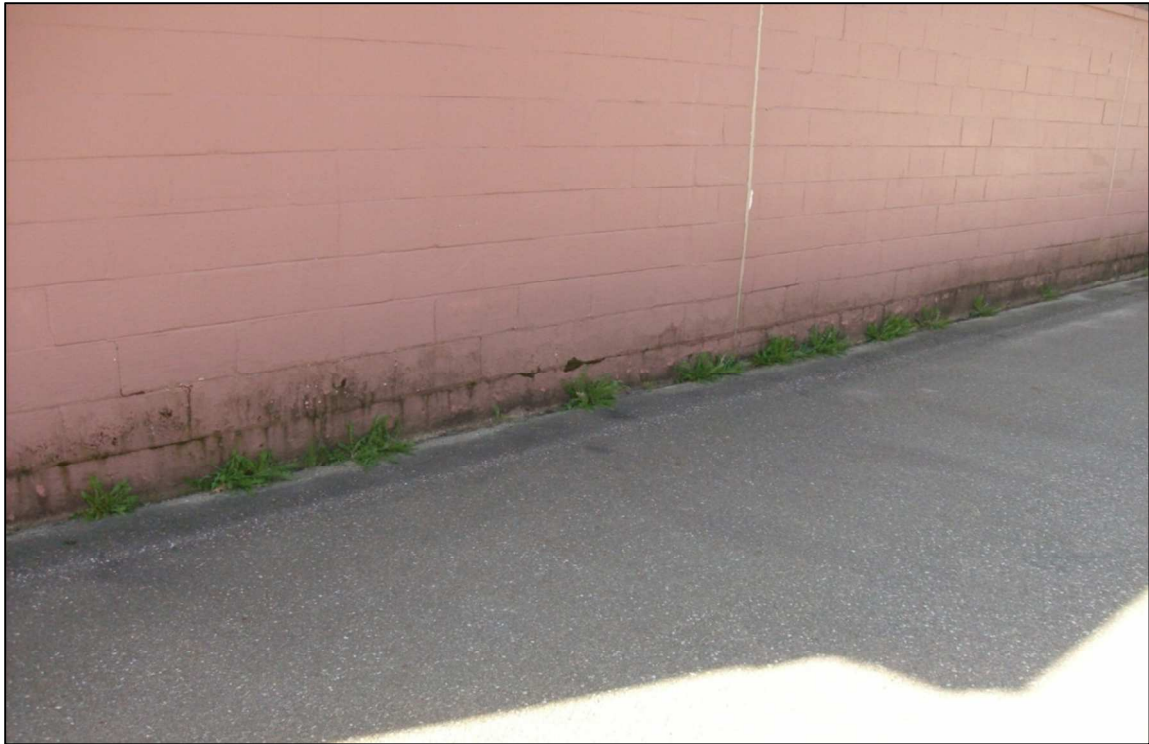
Mold/mildew growth on north side of gymnasium from roof runoff splash back.

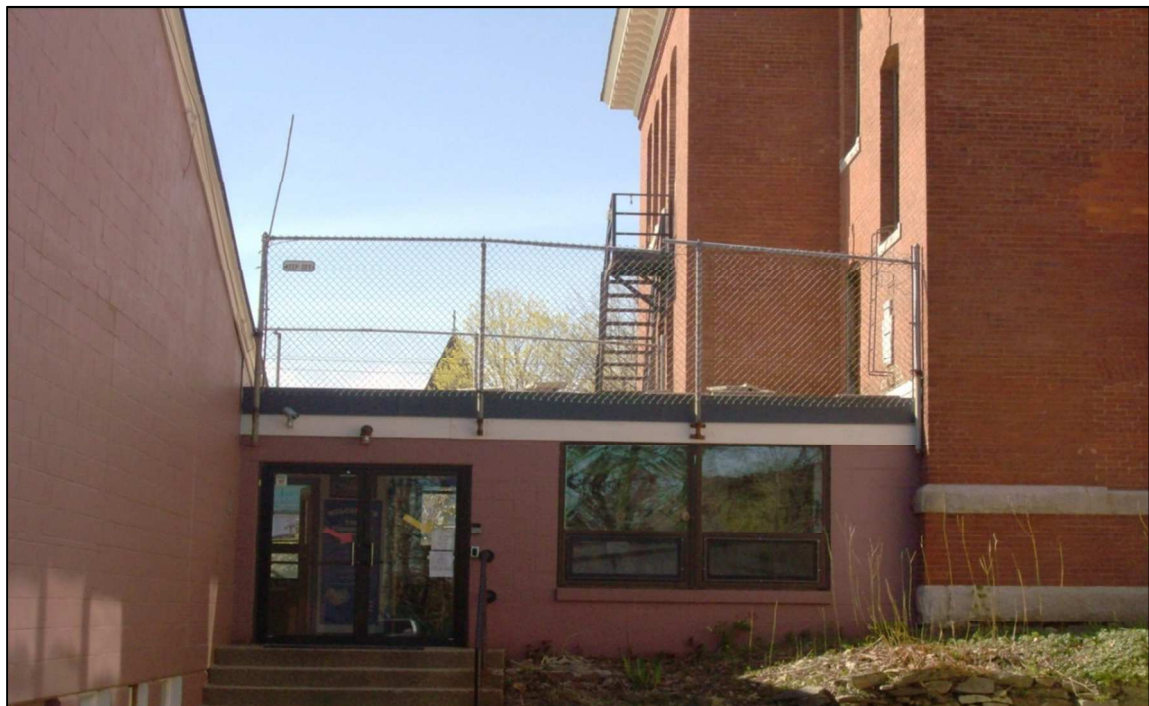
The main entry to the school is through the connector section that joins the original building to the latest addition and it is on the north side of the building. There is no handicap accessibility at the main entrance. Since the grade is high on both sides of the connector building it is relatively easy for someone to get up onto the low roof. To remedy this, the District installed chain link fence across the roof edge of the connector on both the north and south sides of the school. The chain link fence is in disrepair and is unsightly. A more permanent barrier system should be designed, possibly lowering the grades in combination with barrier plantings or other landscape features.

Main entry to school on north side. Chain link fencing is deterrent to easy roof access.

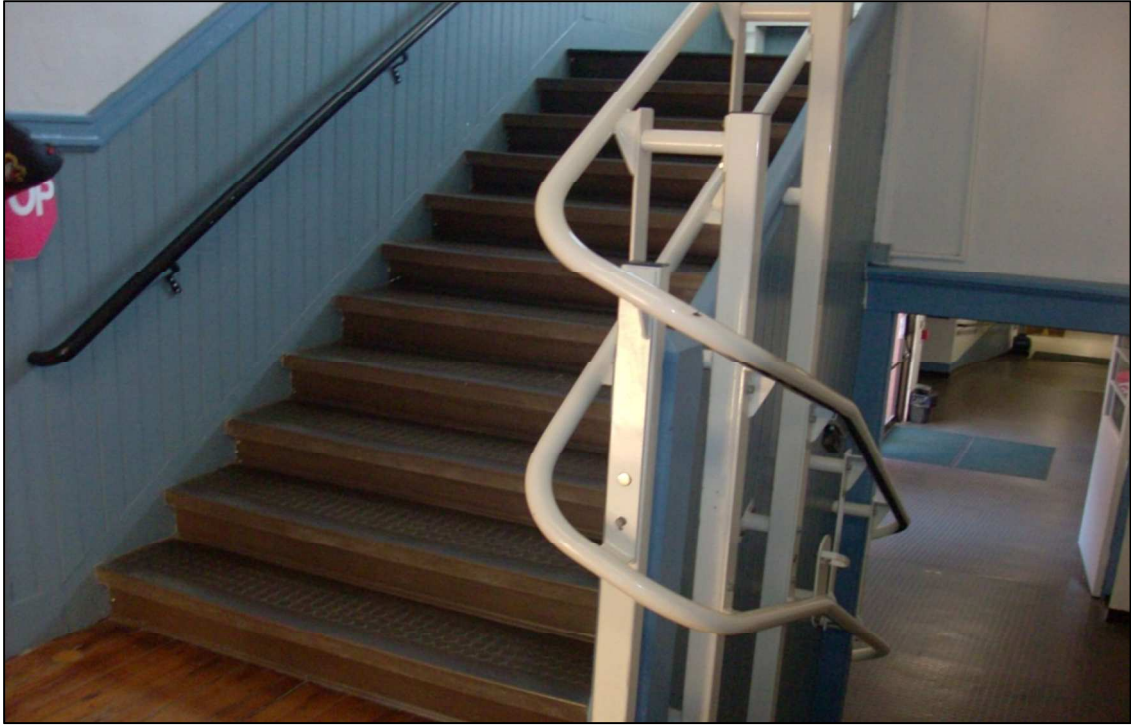
Handicap accessibility between levels is provided by a rail mounted, electric powered stair lift system. The system is cumbersome and impacts the use of the main stair handrails on one side of the stairwell. If budget allows, a more permanent means of access such as a (Limited Use/Limited Application) or an elevator should be added.

Track for stair lift in original section of school.

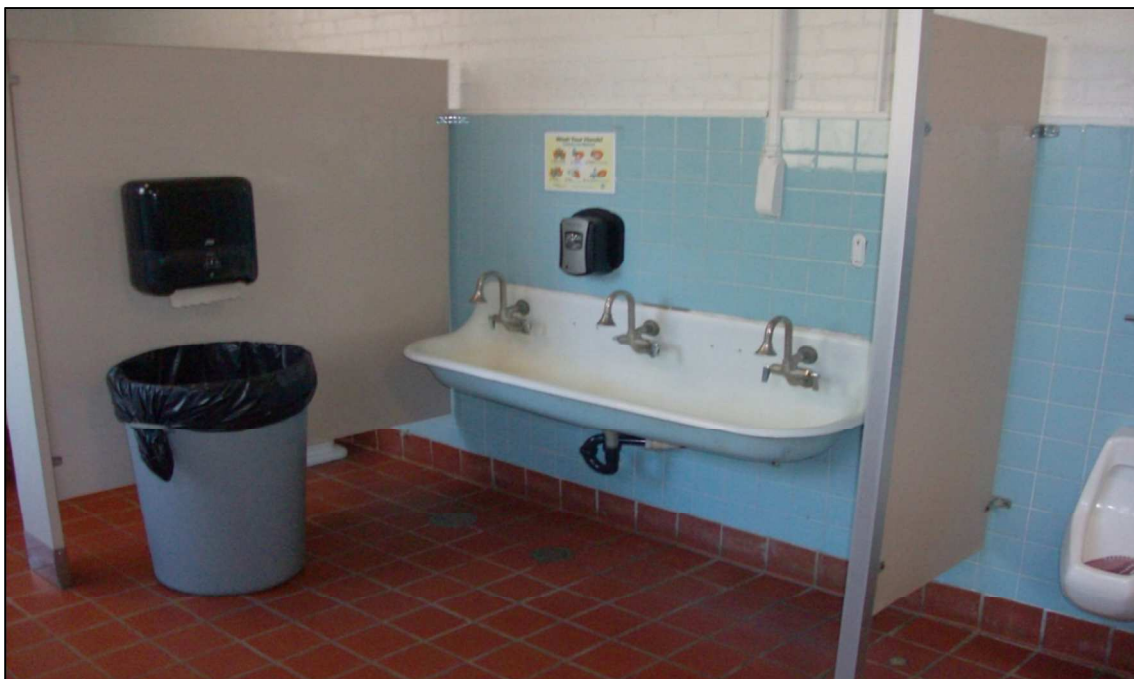
The main bathrooms for boys and girls are located on the lowest level of the original building, accessible from the main level by a half flight of stairs, or a wheelchair lift attached to the stair handrail. The girl’s bathroom entrance at the lower level conflicts with the bottom stair landing. The last riser is past the edge of the opening into the bathroom. The privacy screening half walls at the bathroom entrances conflict with proper ADA wheelchair maneuvering clearances. The girl’s bathroom has a fully accessible stall while the boy’s bathroom lacks a wheelchair accessible compartment. Original trough style lavatories in both bathrooms need to be checked for compliance with ADA accessibility guidelines. Other bathrooms throughout the school do not meet all the guidelines for fully compliant ADA accessible bathrooms.

Outdated fixtures and finishes in lower level boy's bathroom.

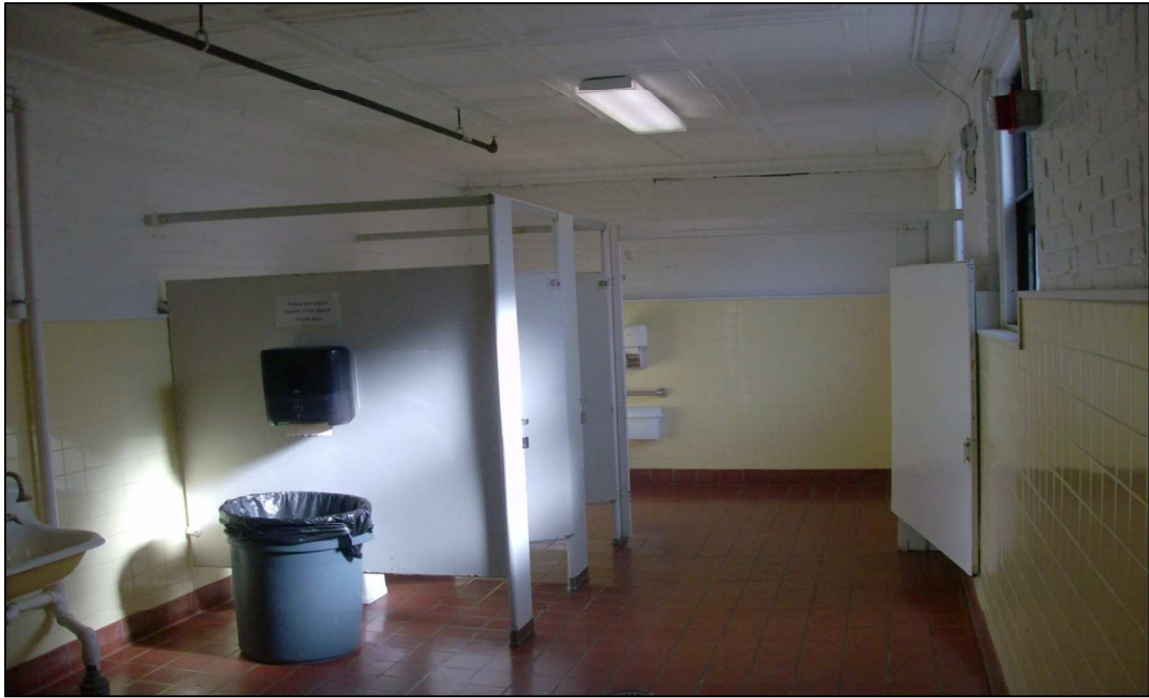
ADA accessible stall in girl's bathroom at lower level.

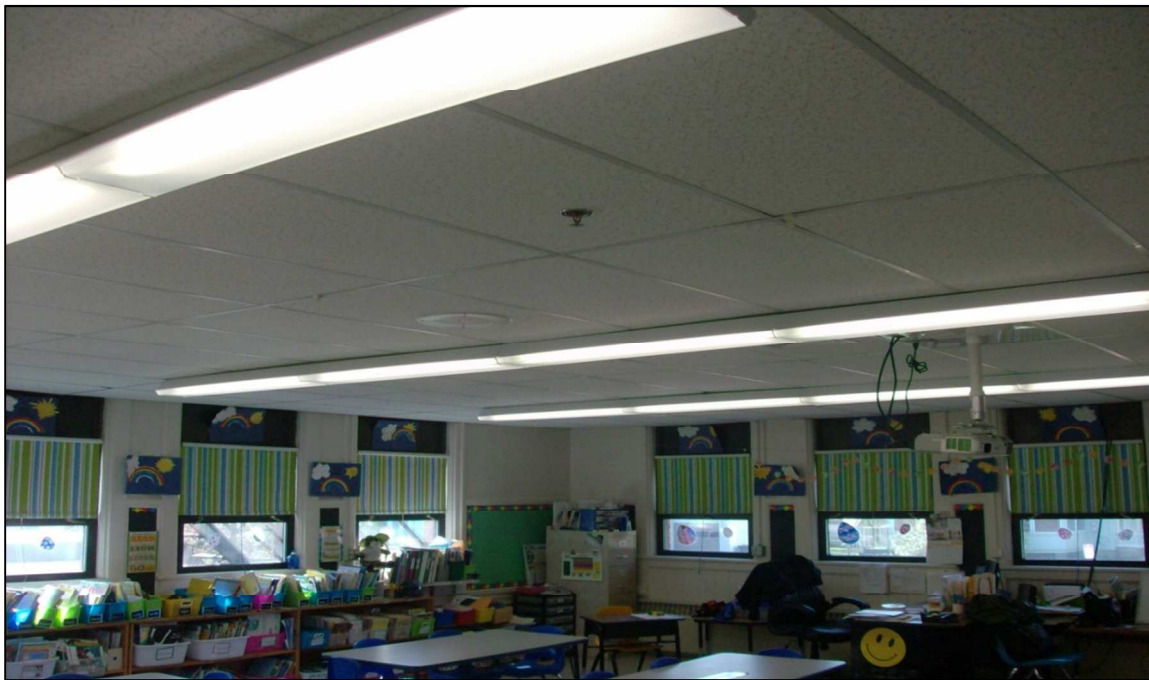
Many of the ceiling finishes are in fair condition. The ceilings are acoustic ceiling tile (ACT) throughout, most likely suspended below existing plaster ceilings in the original school building. Some tiles appeared to be sagging slightly. This could be a sign of excessive humidity at certain times of the year. We did not observe any staining of the tiles. The original tin ceilings in the basement bathrooms need some minor repairs such as edge molding coming off the walls in some locations. Any work on the ceilings may require abatement of the space above the existing ceiling due to the possible presence of hazardous materials. The walls on the upper levels are basically drywall with plaster and paint. On the lower levels, the walls are painted masonry with 4 x 4 porcelain tile on the walls of the bathrooms of the 1930's building. In general, the wall finishes are in fair to poor condition throughout.

Typical classroom with ACT drop ceiling and outdated lighting.

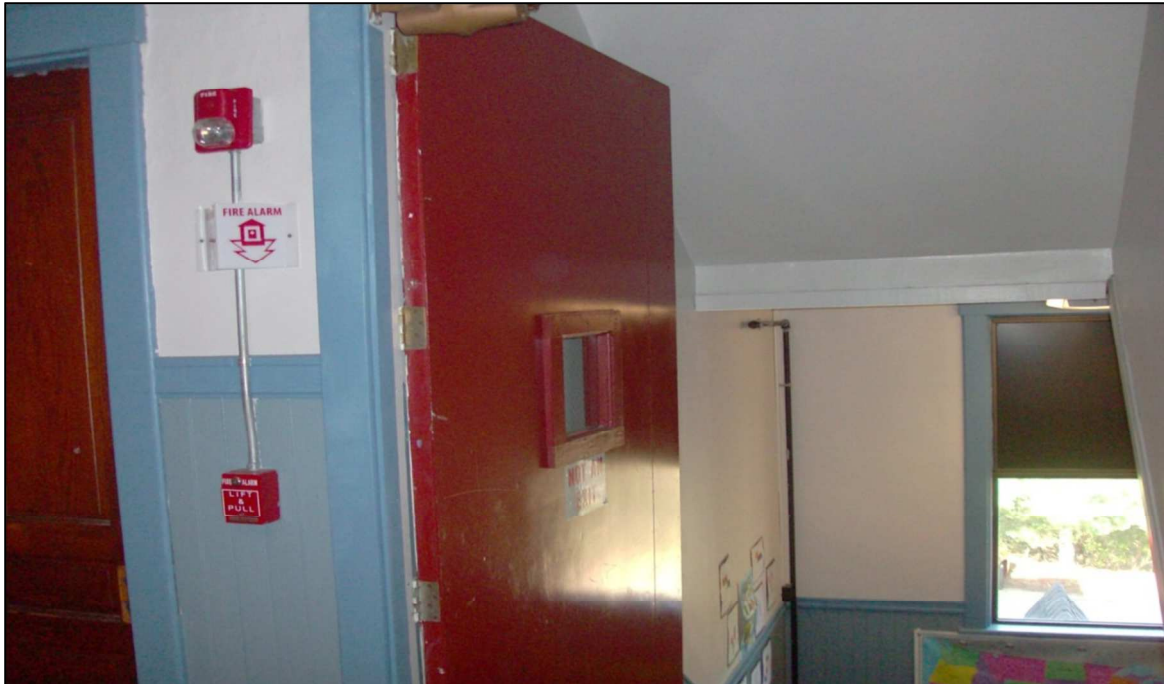
At the original three-story section of the school, the stairs have several major issues. The door at the top of the stairway, designed to act as a fire door, actually swings over the stairs and is coped around the chair lift. This in itself compromises fire/smoke sealing ability and it is questionable whether a student could open the door just based on its size and weight. The top landing should be reconfigured/rebuilt to allow for proper fire door installation, handrail extensions, and chair lift termination. The stairs were originally designed as open stairwells to each of the floors. Modifications have been made to close off the stairs from the top and bottom levels; however, location of stair enclosure doors/walls do not allow for modern code clearances typically associated with stairs, landings and handrails.

Large heavy fire door at top of stairwell in original section of building.

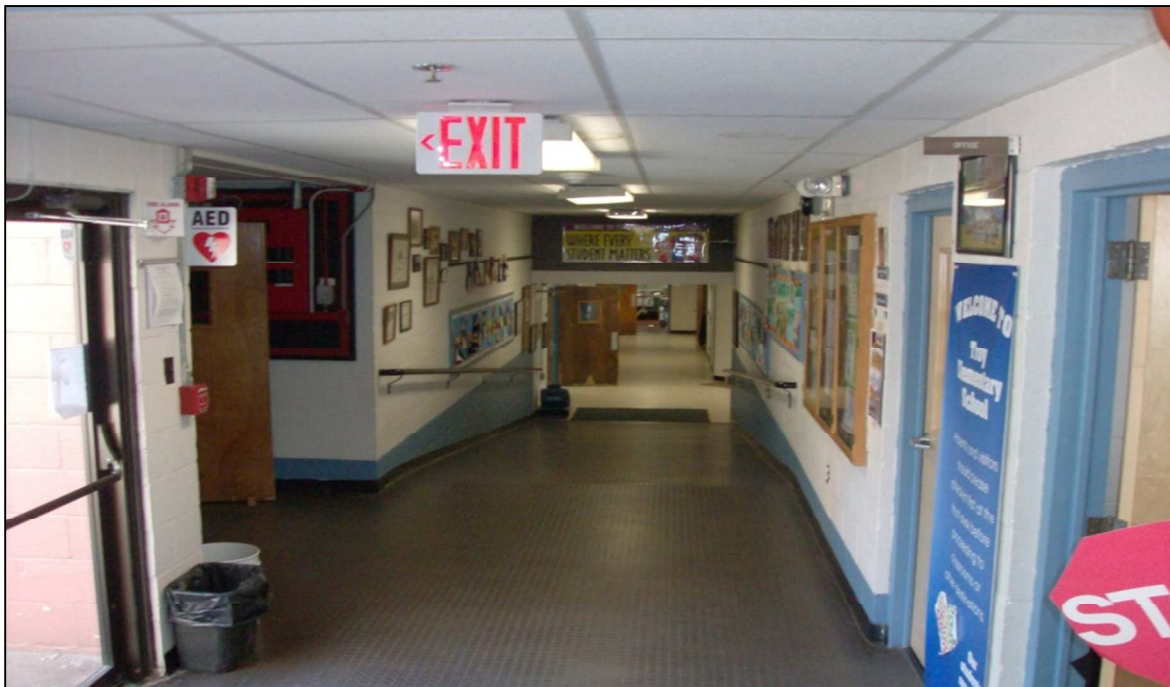
Ramp in connector between original building and 1970's addition. Main entry is on the left.

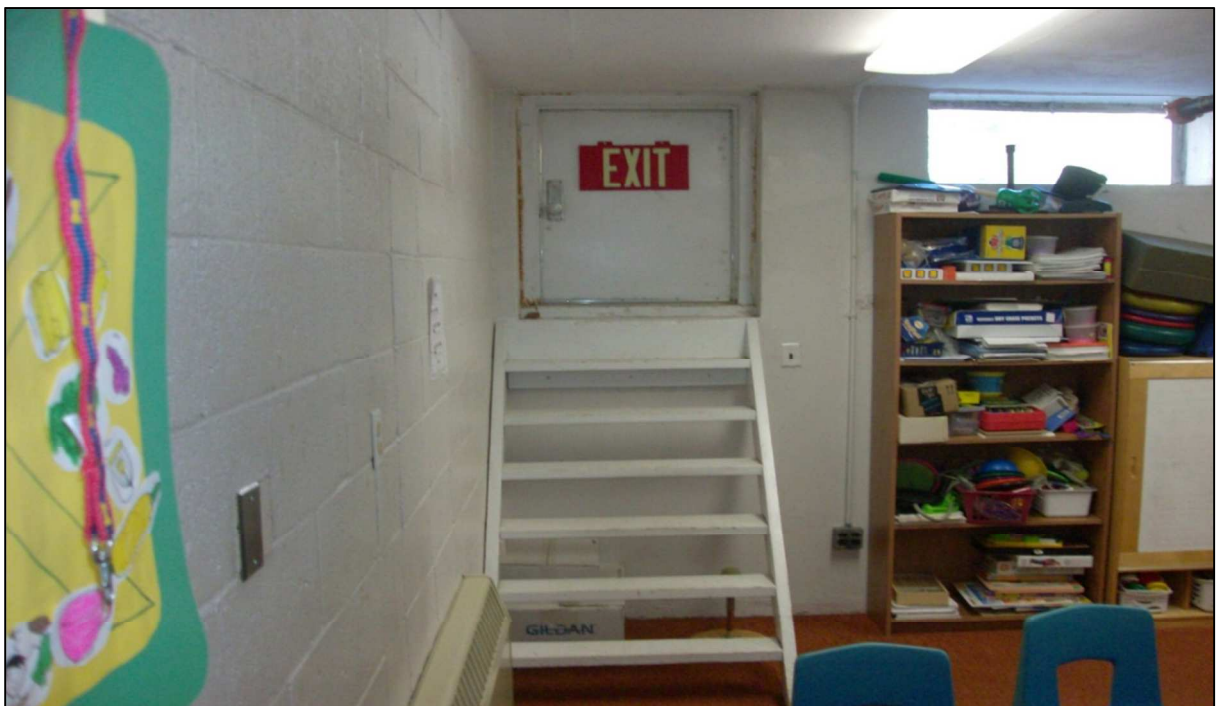
There is an area beneath the stage that originally served as locker rooms and actors prep rooms, that is currently used for a staff break room and special instruction area for individual students or small groups. There is no handicap accessibility to these spaces beneath the stage. Egress is another concern. There are access panels in the walls with fixed steps leading through the foundation wall to the exterior to provide the needed egress. Although not ideal, it does meet the criteria.

Emergency exit from lower level below the stage.

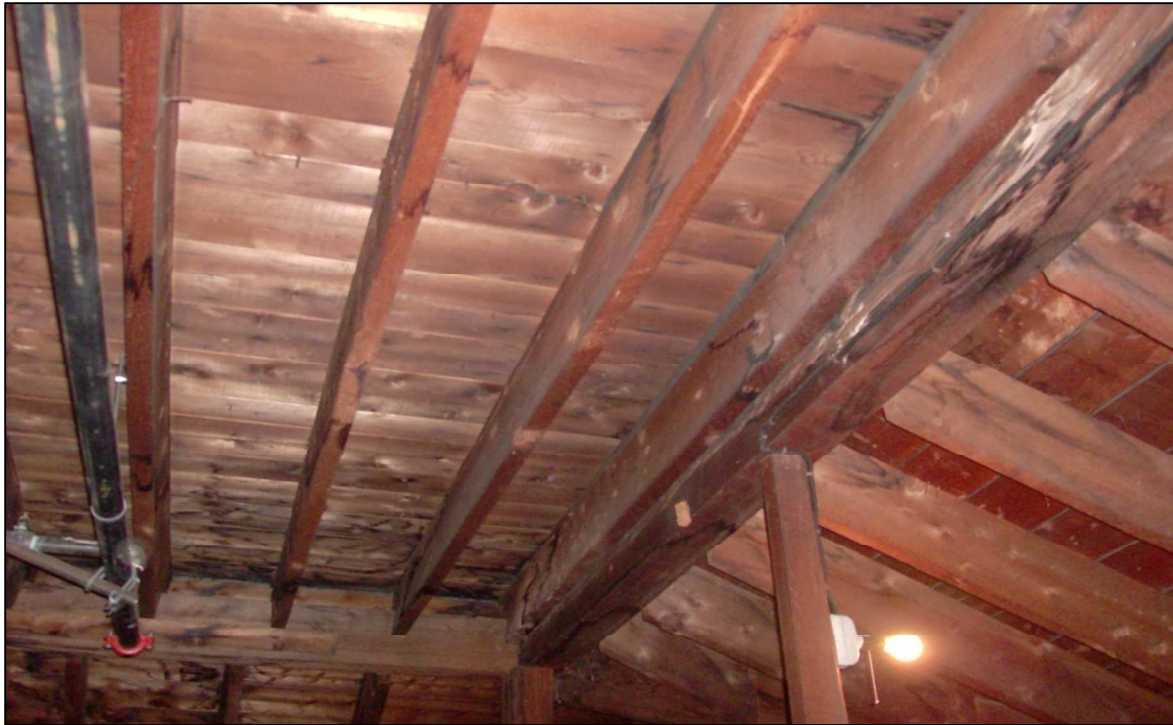
Typical wood framing in the attic. Wood staining may indicate past leakage.

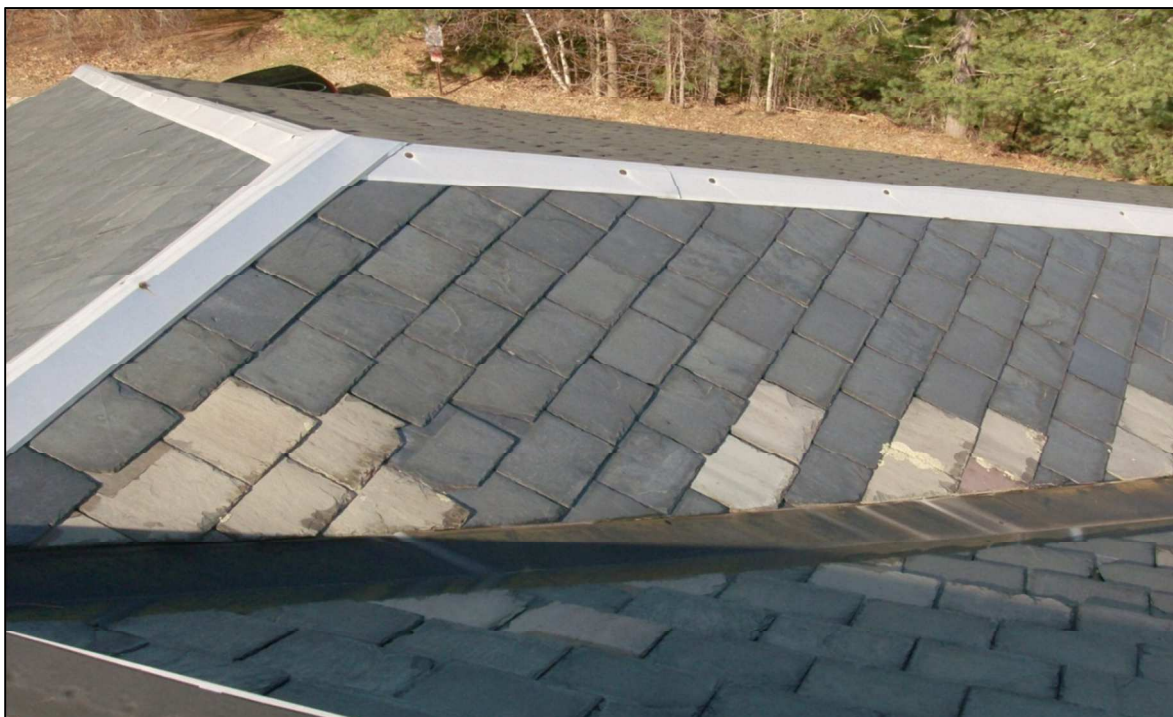
Most of the slate is in good condition although there is evidence of some slate tiles that have been replaced over the years along the roof edges and in the valleys. The areas previously replaced are those areas subjected to ice damage. Along the roof edge instead of replacing the slate, a metal ice band was added. Currently there are several slate tiles along the roof edges that will require replacement in the near future and the metal roof edging should be installed similar to what has already been done. The roof flashing at transitions and valleys appear to be in good condition and well maintained. The roofs of the 1930's addition as well as 1970's addition are covered with membrane type roofing. The former is an EPDM rubber roof in good condition, while the later appears to be a white TPO roof. The roof drains and drain sumps appear to be free of debris and the strainers were in good shape. Despite this fact, on the day of our observations, there were many ponding locations throughout the roof and the TPO was heavily stained. At the connector roof there were pavers placed over the membrane and there appeared to be an egress path from one of the second floor roofs to the connector roof. The gymnasium/cafeteria roof is pitched, with standing seam metal roofing on the south side and asphalt shingles on the north side. The standing seam roof, including the rows of snow guard, is in good condition, while the shingles on the north side are nearing the end of their useful life, and will require replacement in the next four to five years. The metal roof fascia at the flat roof over the classroom section is in good condition; however the wood beneath the metal is peeling in places and should be repainted.

Slat roof over original building. Note replacement slate along the valley.

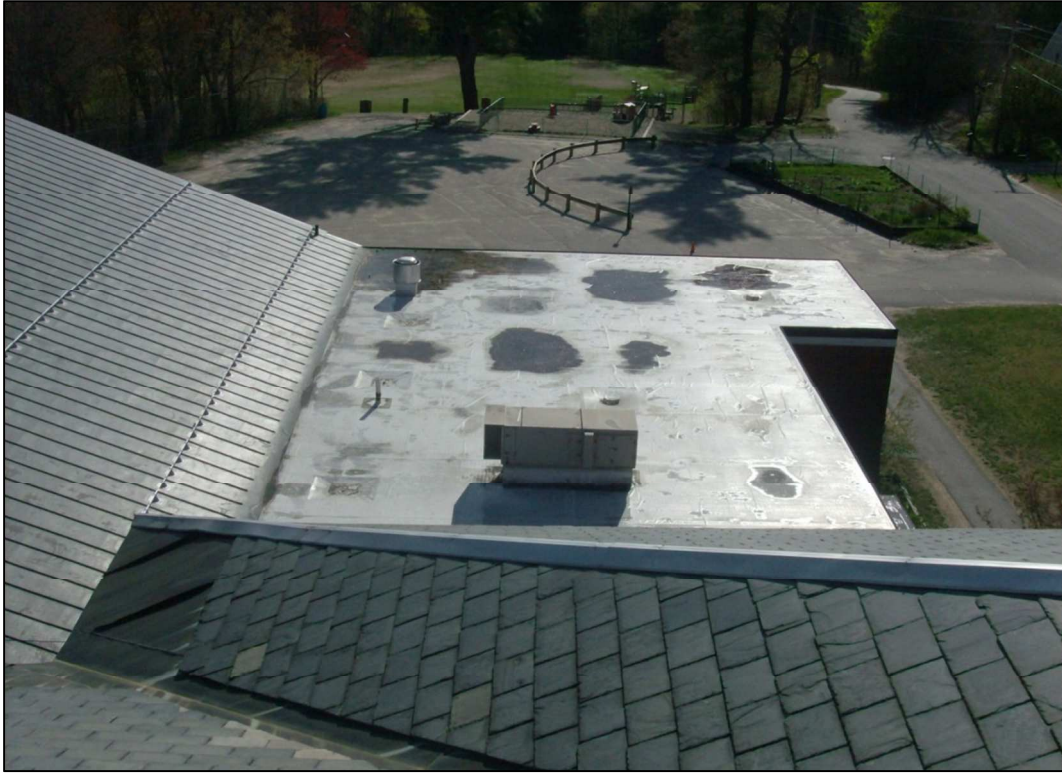
Looking east from original building toward the 1970's addition. Note metal edging along slate roof, water ponding on 1970's TPO roof, and metal roofing with snow guards on gym to the left.
