DRAFT REPORT

EVALUATION AND ASSESSMENT EMERSON ELEMENTARY SCHOOLS 27 RHODODENDRON ROAD FITZWILLIAM, NEW HAMPSHIRE

Monadnock School District
Emerson Elementary School
27 Rhododendron Road
Fitzwilliam, New Hampshire

Facility Assessment

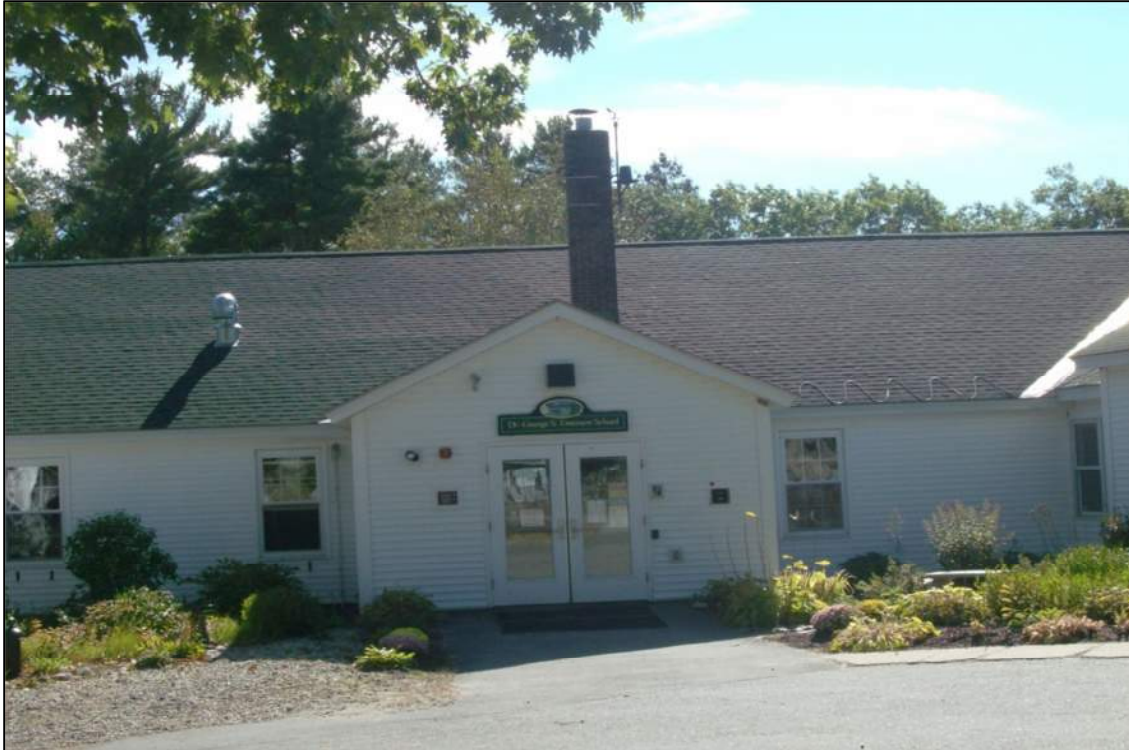
Main entry to Emerson Elementary School.

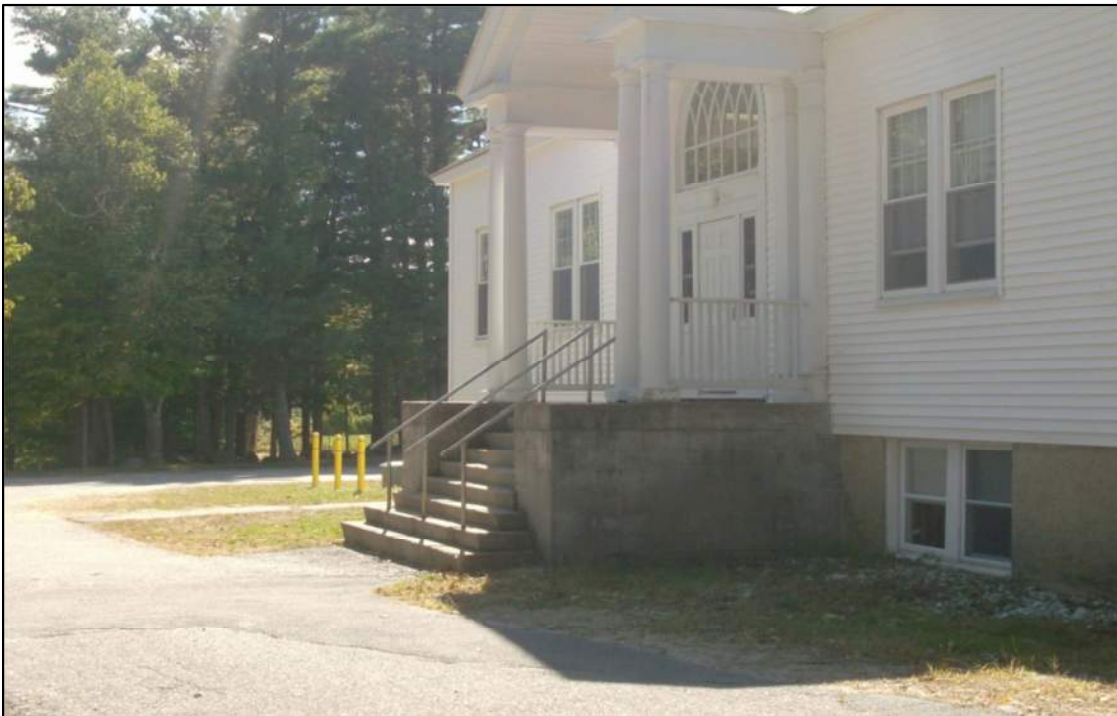
The original main entry to the school on the west side has a set of concrete stairs. The stairs are very steep and shallow and do not comply with current code for acceptable rise and run dimensions. Although this entry is no longer used for access into the building, it does serve as an emergency egress path. Eventually the stairs should be reconfigured to meet code requirements.

Former main entry on east side. Stairs are non-compliant.

- Reconfigure entry stairs on west side of building (i.e. original entry to school) \$100,000 to \$120,000
- Add new boiler in 1999 wing to supply ERV's and eliminate long runs of piping from original boiler room..... \$125,000 to \$150,000

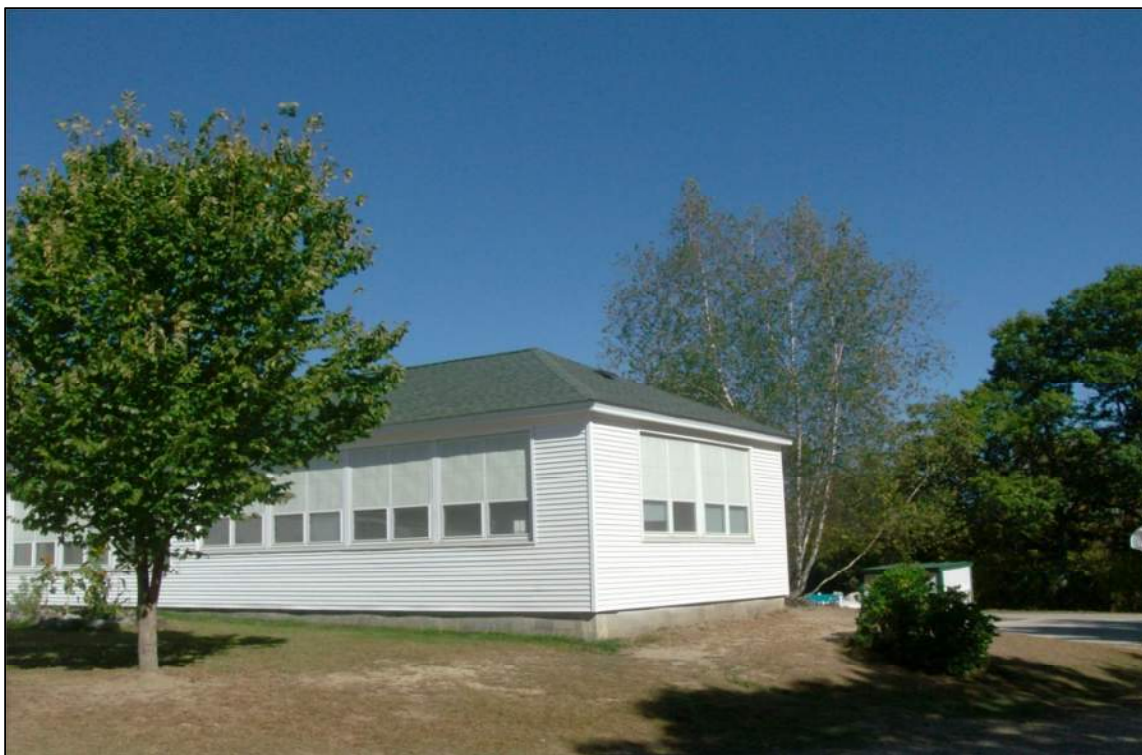
1950 wing on south side with newly shingled roof.

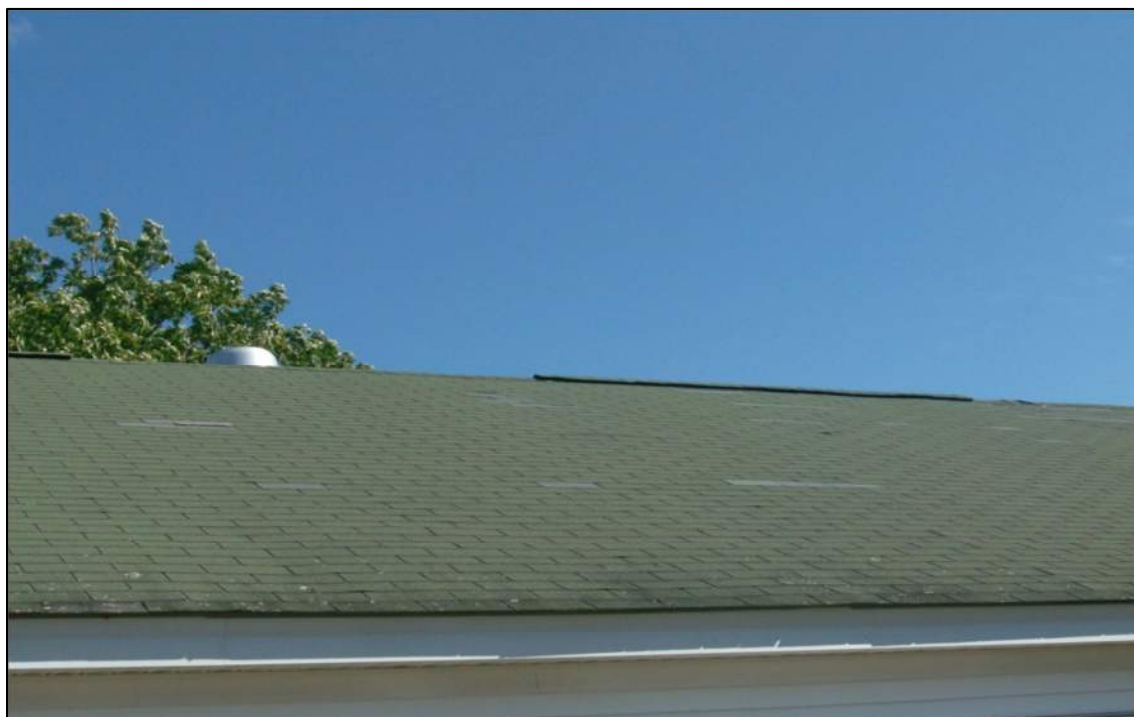
top of the shingles. The three tab style shingles are in poor condition as we observed missing shingles, mildew staining and lichen growth. We estimated that approximately 20,000 square feet of roof shingles will require replacement in the next 4 to 5 years. There is faux standing seam EPDM membrane roof over the chair storage room that appears to be in good condition; however some of the glued-on seam strips are missing.

Most of the roofing needs to be replaced.

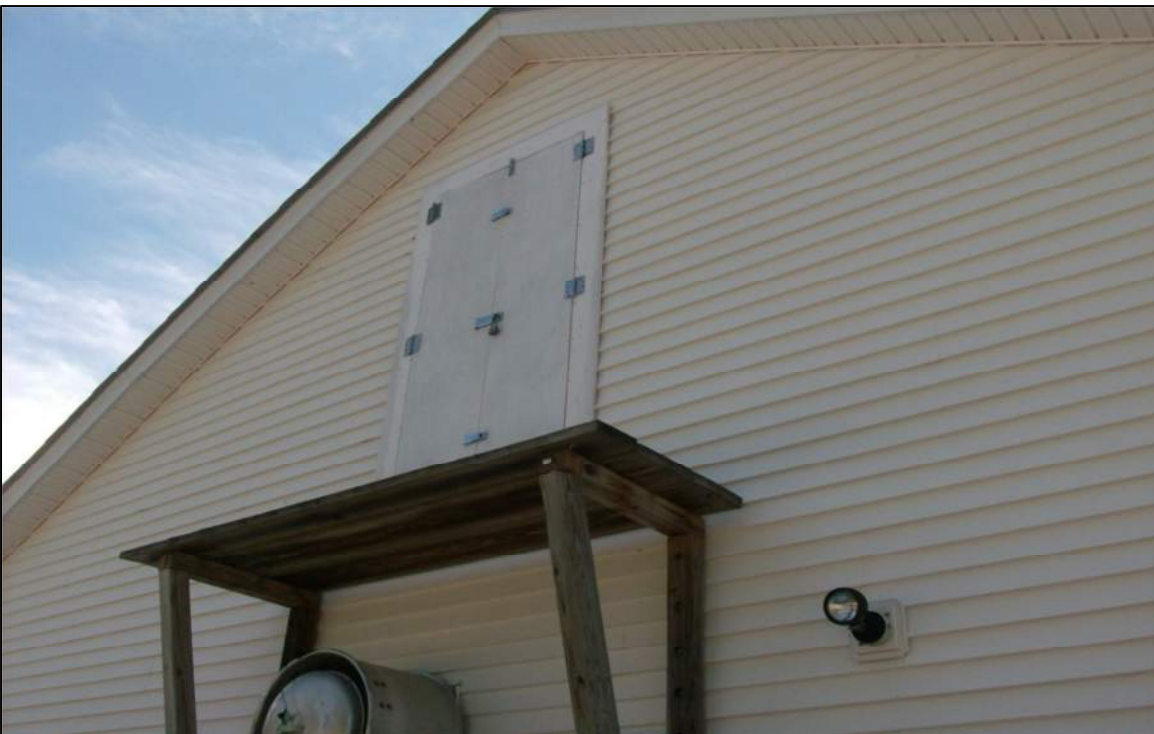
On the north side of the kitchen there is an elevated wood framed platform in front of a set of double doors supported off the gable end of the building. The double doors provide access into the attic space in order to service some mechanical equipment over the kitchen. The wood platform has no permanent stair or ladder access and does not have any guardrails around the perimeter. This entire means of access into the attic should be re-designed with personnel safety in mind.

Platform to access HVAC unit over kitchen. No handrail makes this particularly dangerous.

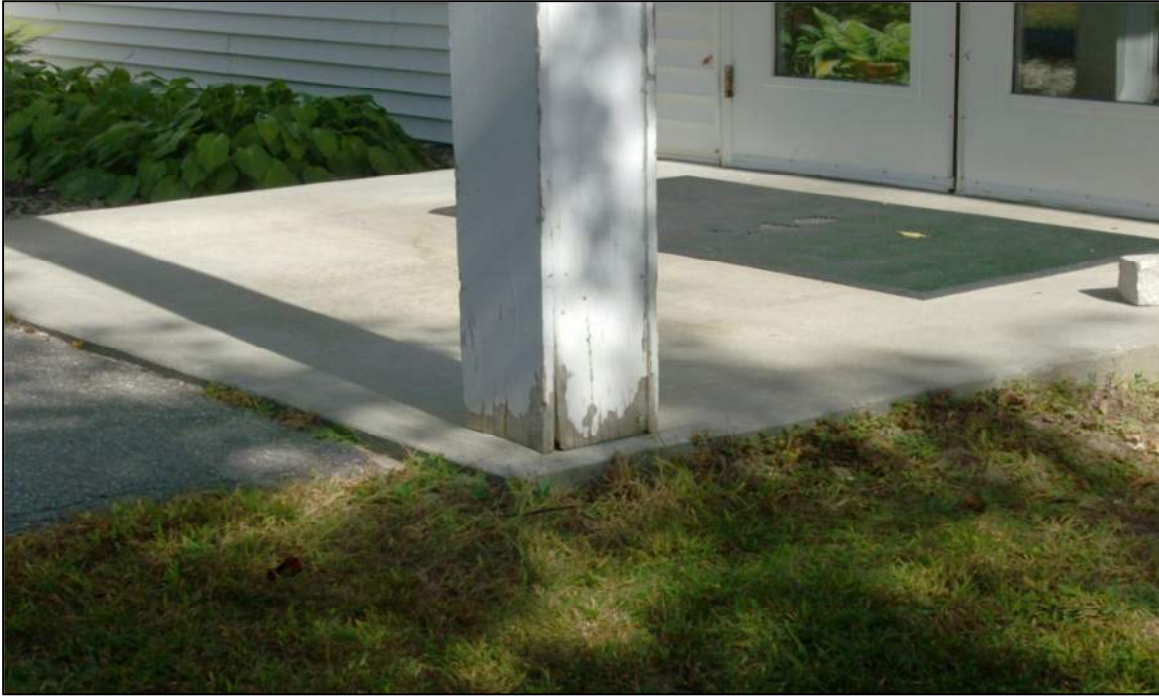
There was daylight visible between the door leafs of the main entry into the vestibule on the north side of the building. There were also gaps along the bottom of the doors. The astragals and weather seals should be replaced to help prevent cold air from infiltrating the vestibule. There is an entry door on the east side of the building just to the south of the multi-purpose room. The paint on the wood posts that support the entry canopy is peeling at the bottom where the posts contact the concrete slab. The posts should be scraped and painted and any rotted sections of trim should be replaced.

Posts at west entrance needed paint and showed signs of wood rot.

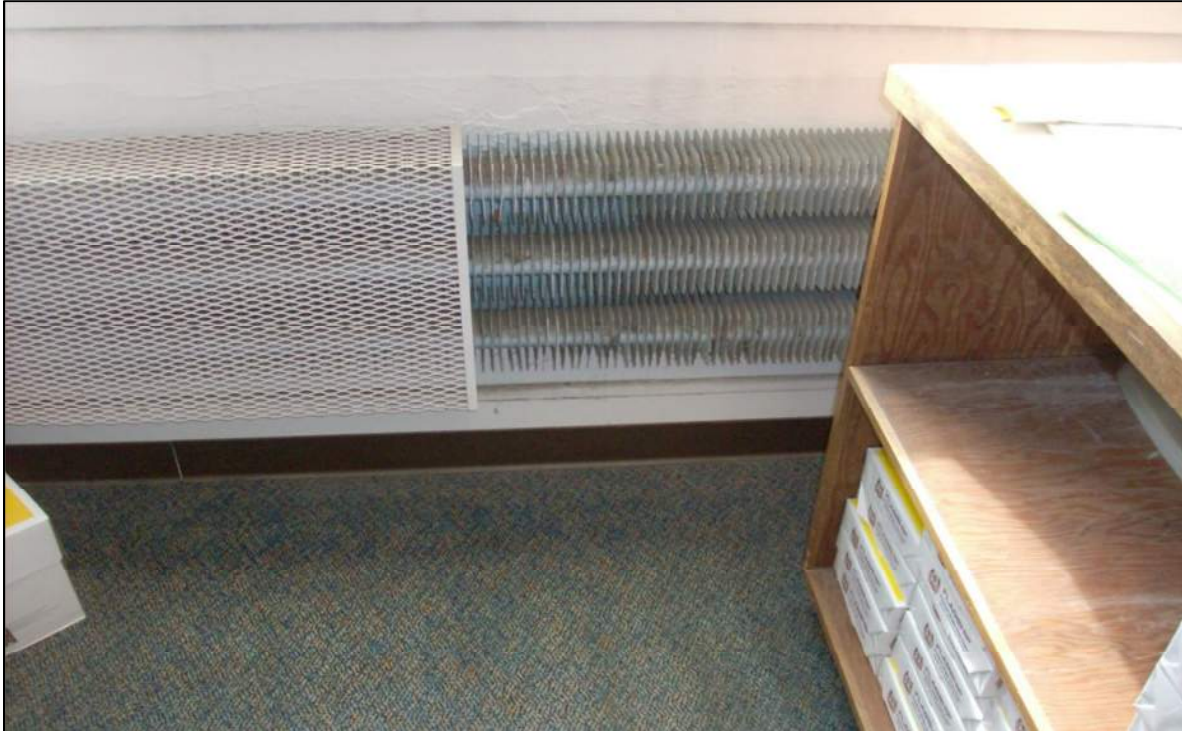
Typical fin tube radiators in older sections of school.

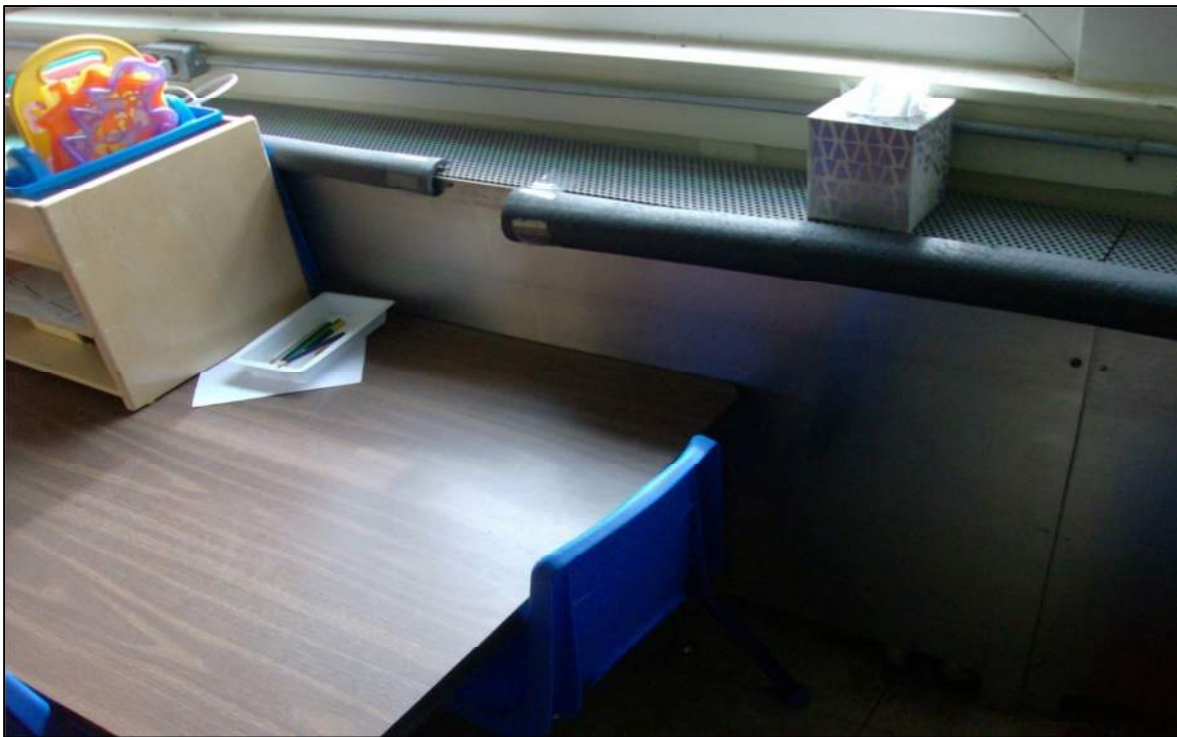
Fin tube radiators with vented covers.

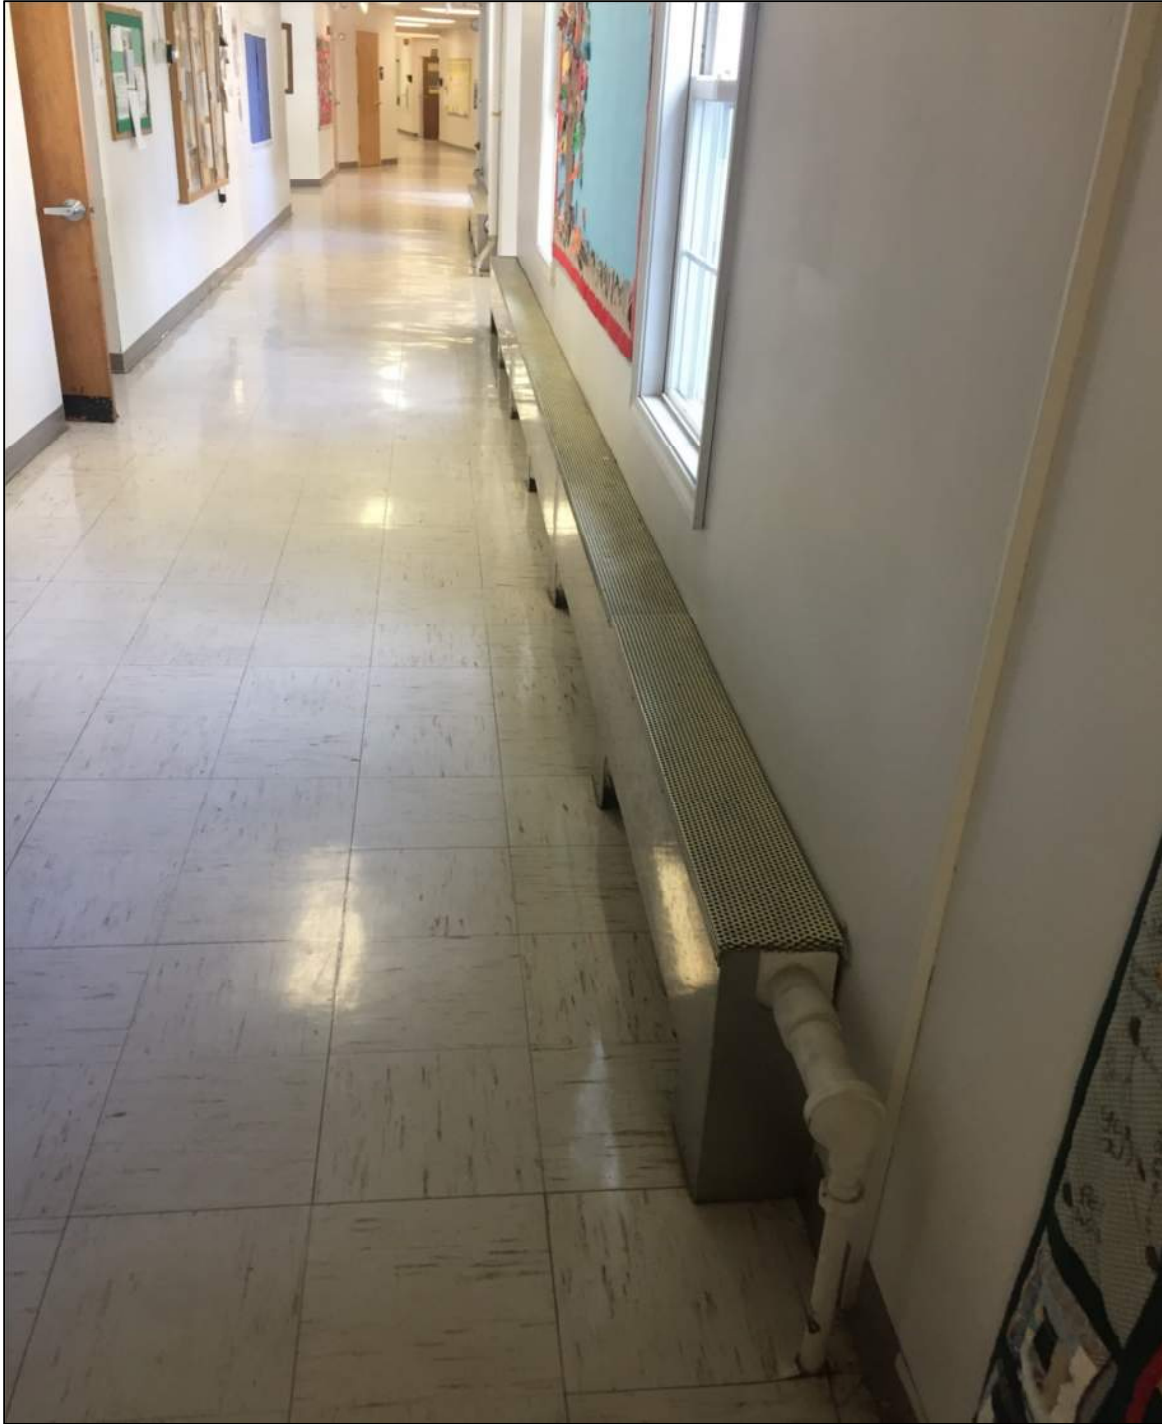
Fin tube radiators in corridor.

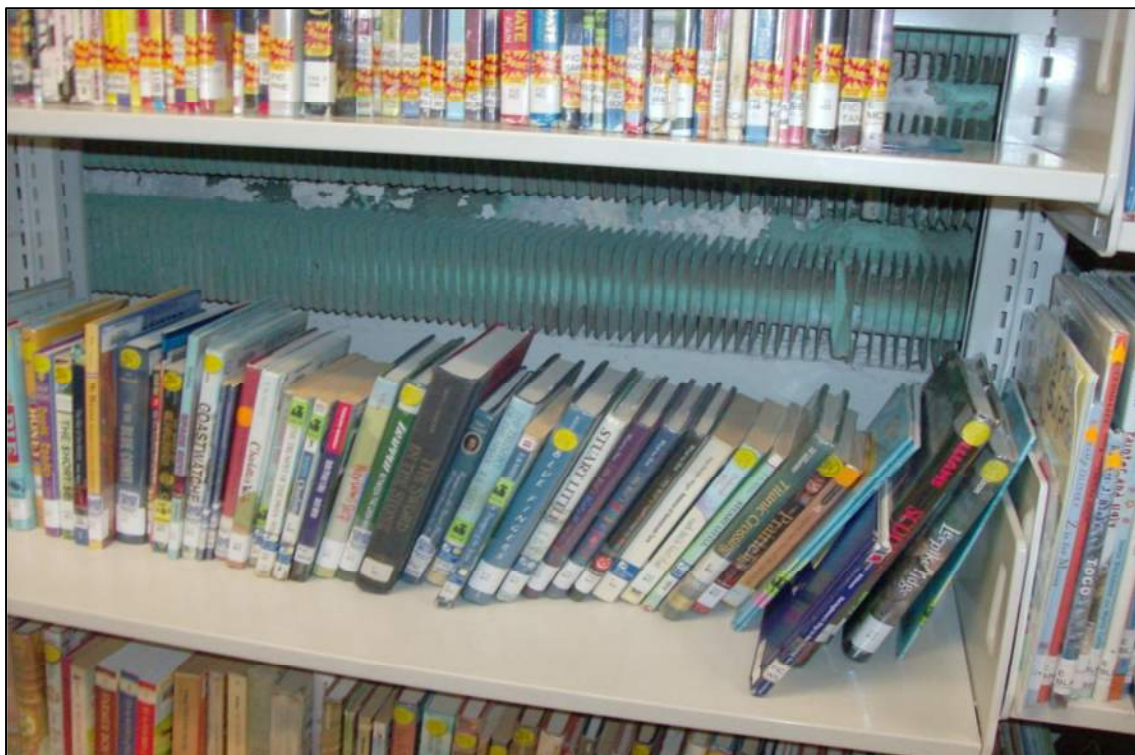
Heating in all but the 1999 addition to the school, including the corridors, is through hot water piping and fin tube radiators. In the classrooms, some of the fin tube is covered by shelving and bookcases which cuts down on its effectiveness. In the library there are fin tube sections behind some of the bookshelves. Even though an attempt has been made to limit the placement of books in front of the fin tube radiators, there is some blockage, reducing the efficiency of these units. In other locations there are dented or blocked covers that should be addressed for better air flow. The original boiler was replaced in 1987 with a three module, oil-fired boiler with three circulator pumps. Several years ago, the boiler was converted over to burn natural gas. Rooftop fans exhaust air from the bathrooms and classrooms, but there was a lack of fresh air supply to the original and 1990's addition.

Fin tube behind bookshelves of library.

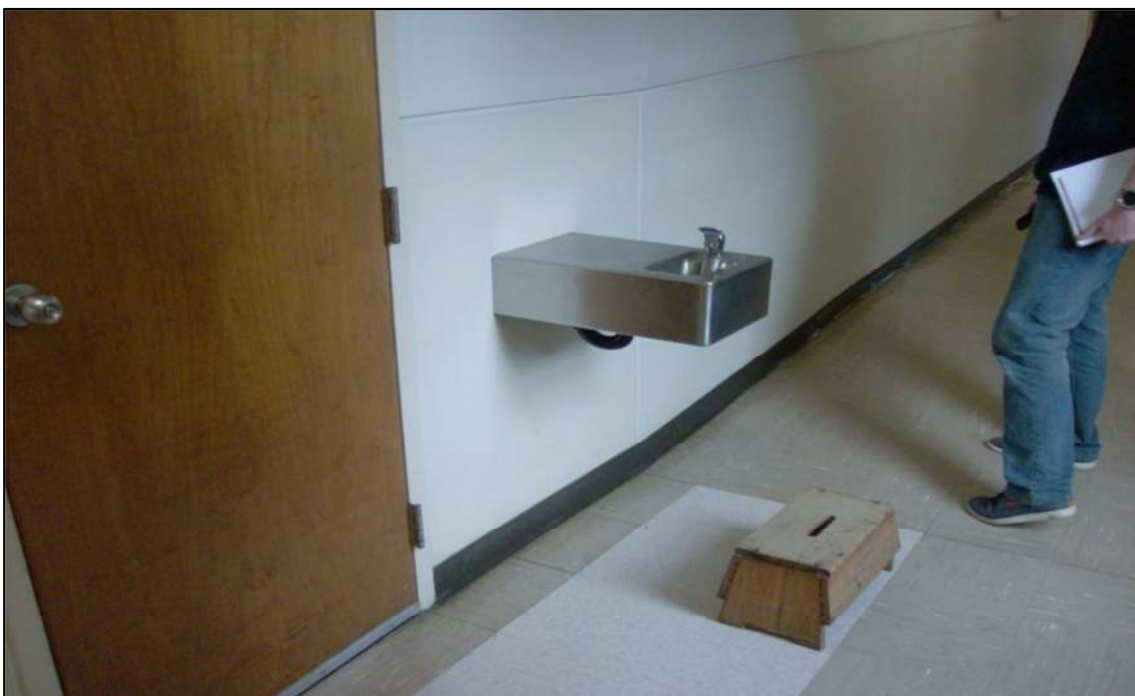
Drinking fountain extends out into corridor and creates an obstruction.

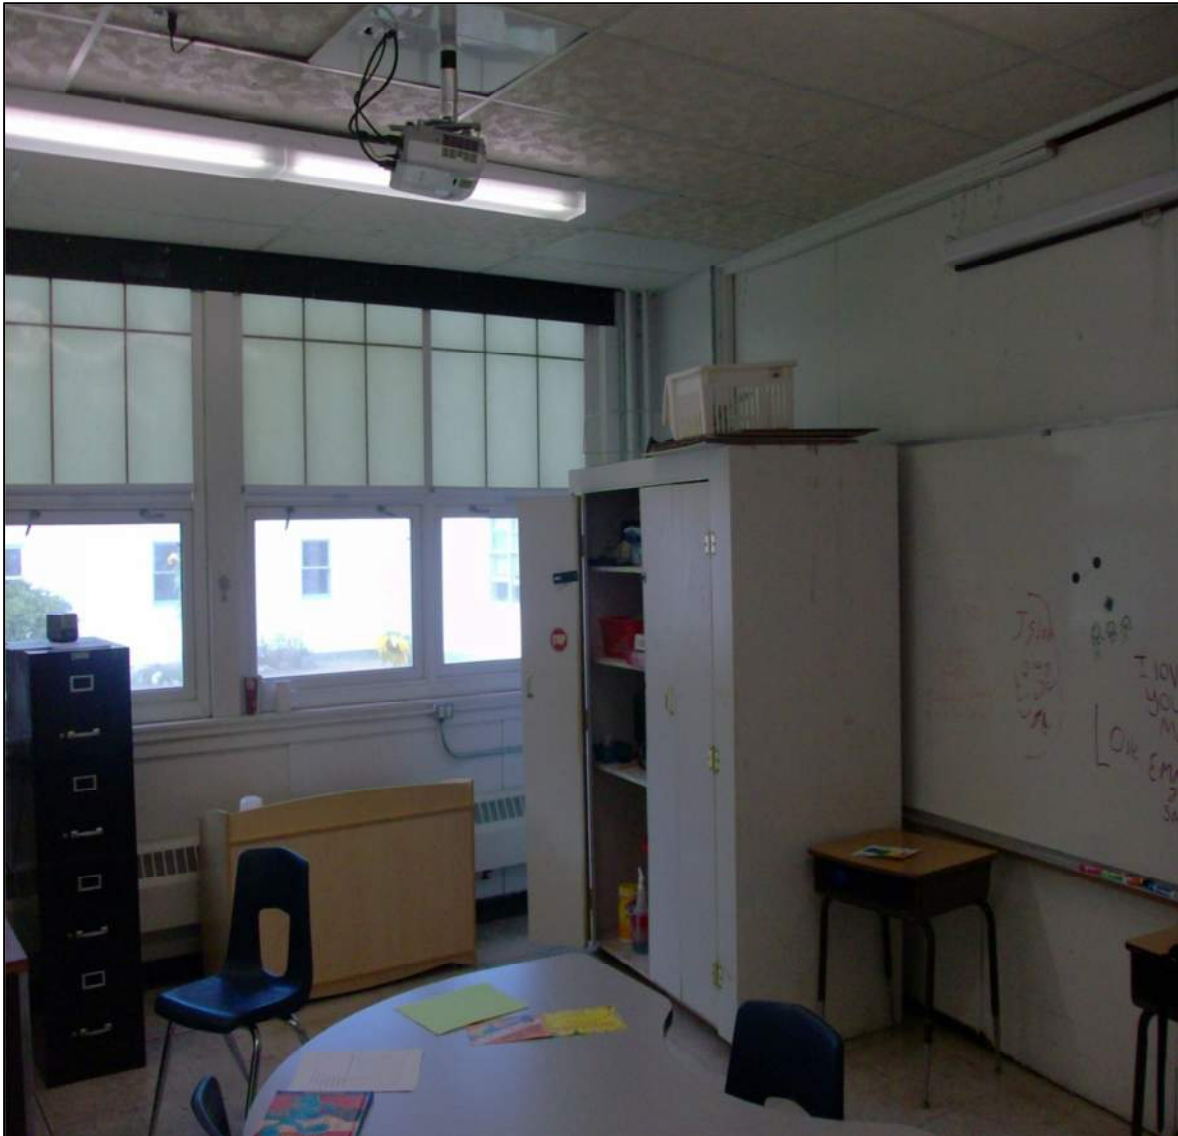
infill band of Kalwall directly above the window glass. The Kalwall panel extends up above the ceiling level and there is a gap between the ceiling panel and the window unit. The hopper-style windows are leaky and do not provide a good seal. These windows along with the Kalwall inserts should be replaced within the next 2 to 3 years. The Kalwall components can be replaced with an insulated metal panel and the window should be upgraded to a new energy efficient unit. The 1999 wing is a combination of vinyl double-hung windows, awning windows in the kitchen, and fixed style windows in the multi-purpose room. These windows are about 18 years old and the flashings, j-trim, etc., all are in good condition with no leaking or failed seals observed. These windows should be adequate for the next 8 to 10 years.

Old hopper-style windows with Kalwall panels above.

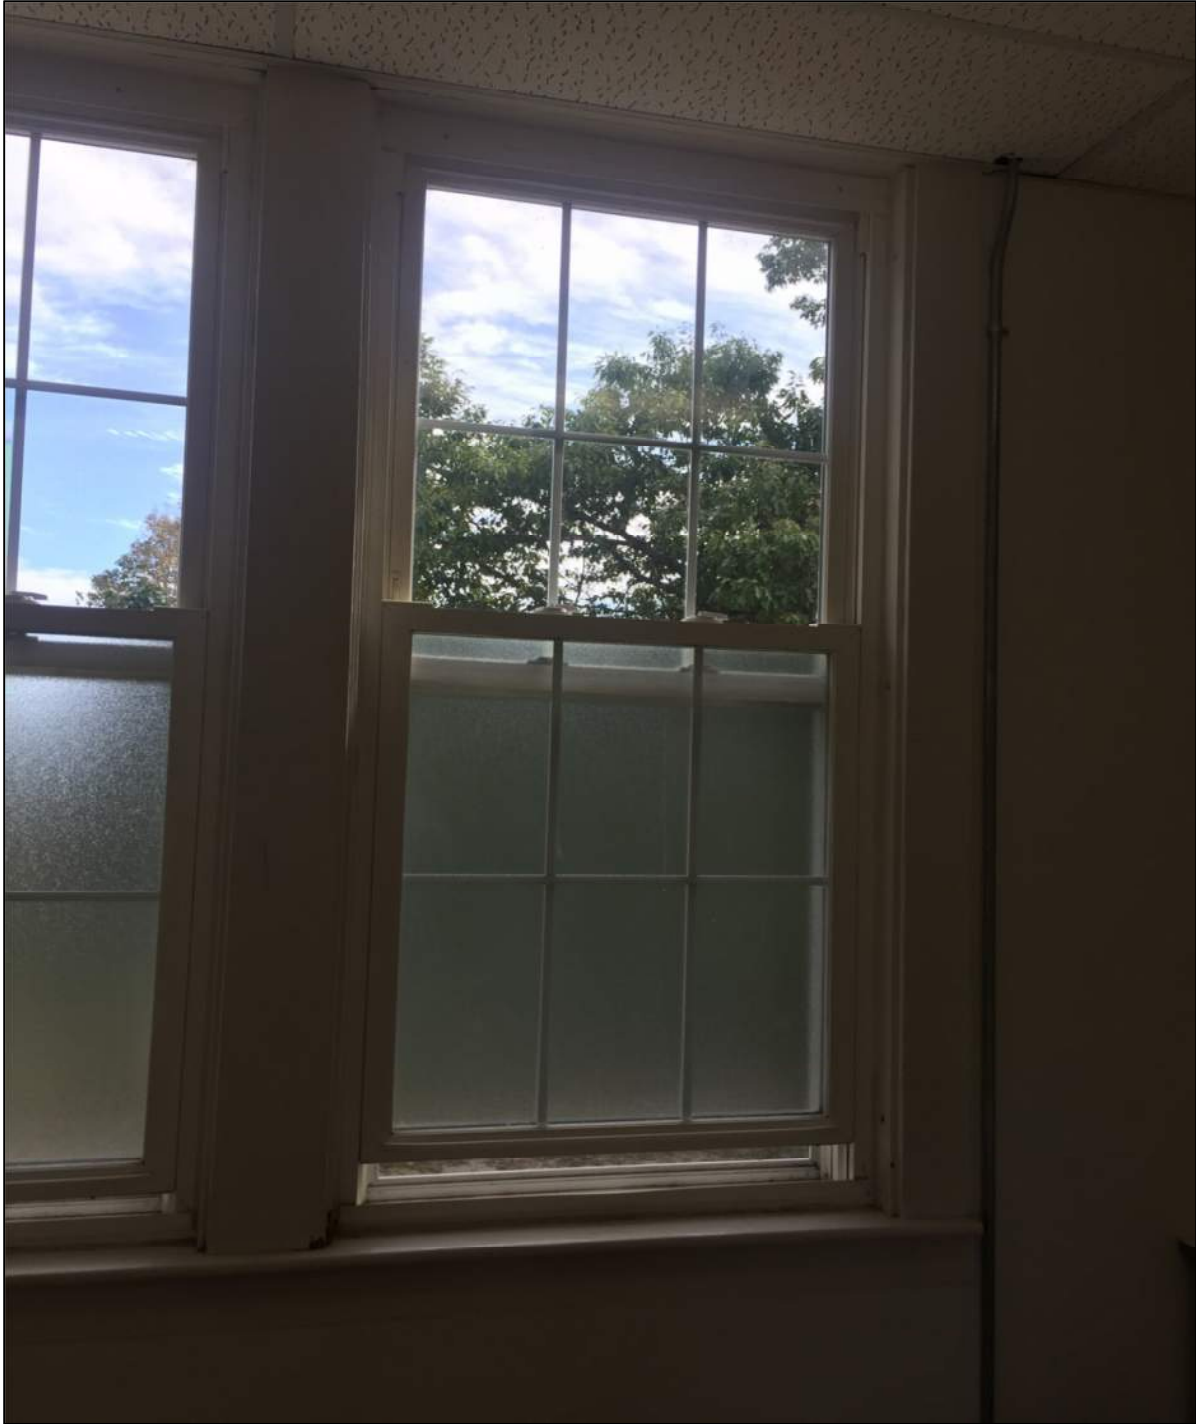
Old double-hung style windows in section of original school.

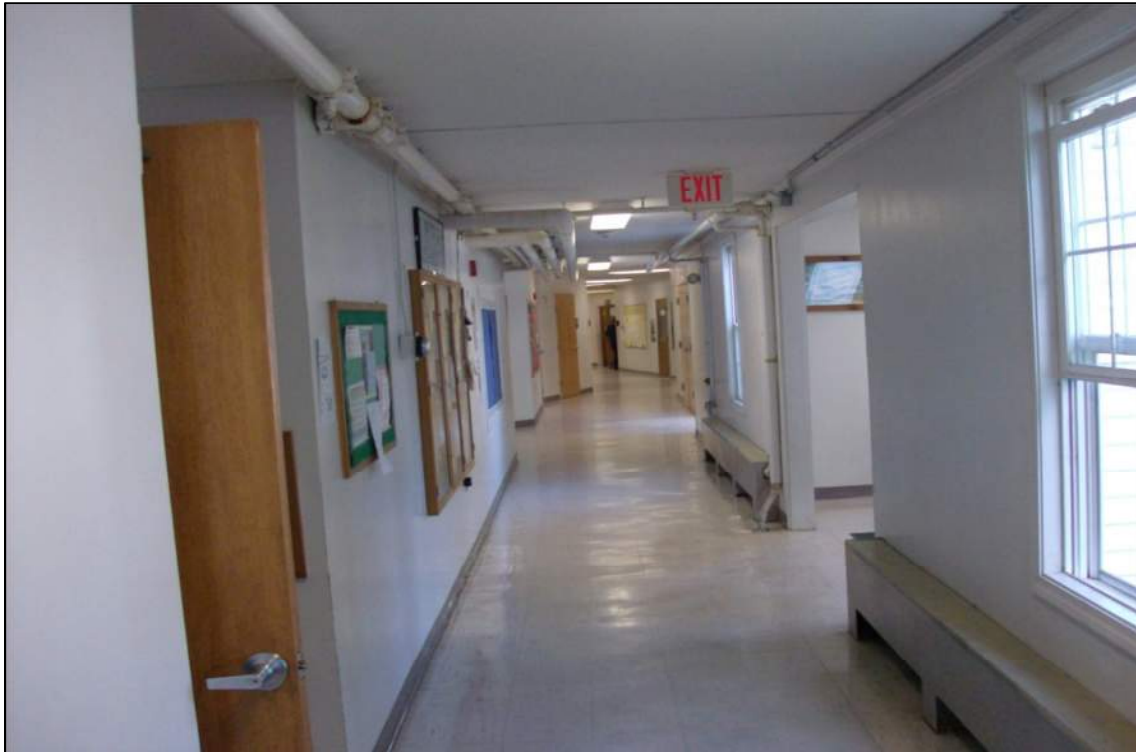
Hot water supply and return lines run from the original 1925 boiler room all the way to heating coils in the ERV ductwork, as well as to heating coils in ceiling mounted heaters over the entry doors of the new addition. Some of this piping hangs below the drop ceiling. It would be advantageous to locate a boiler in the 1999 wing to allow for removal of this unsightly piping that hangs below the ceiling.

Note exposed sprinkler and heating pipes below ceiling.

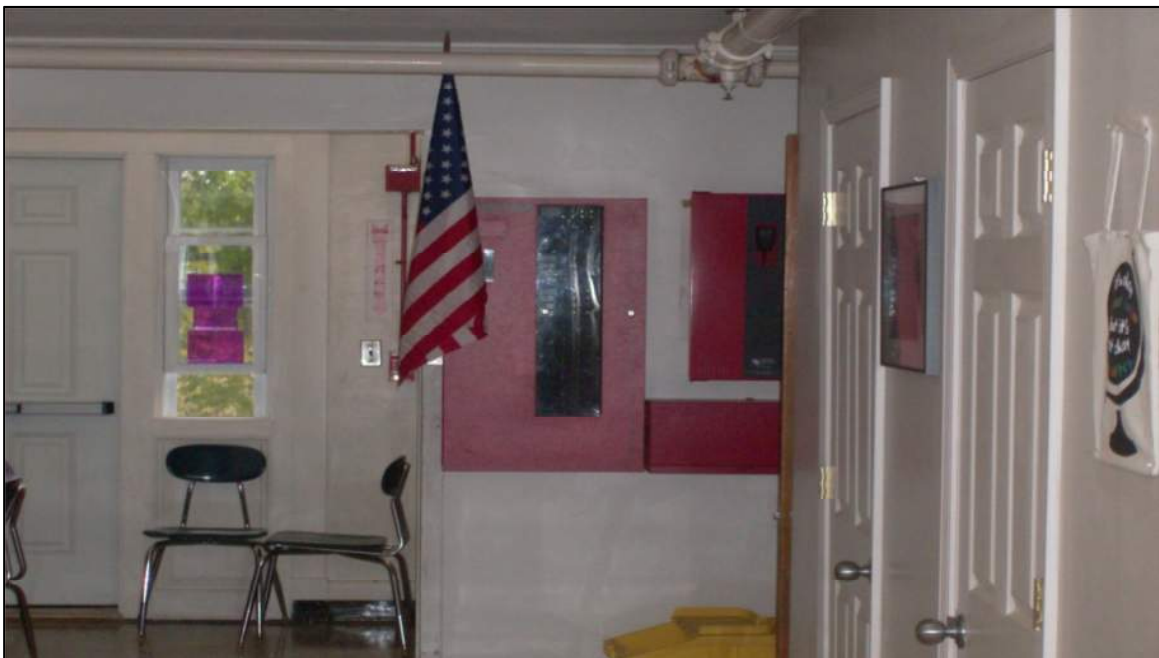
Fire alarm panel in original section of school.

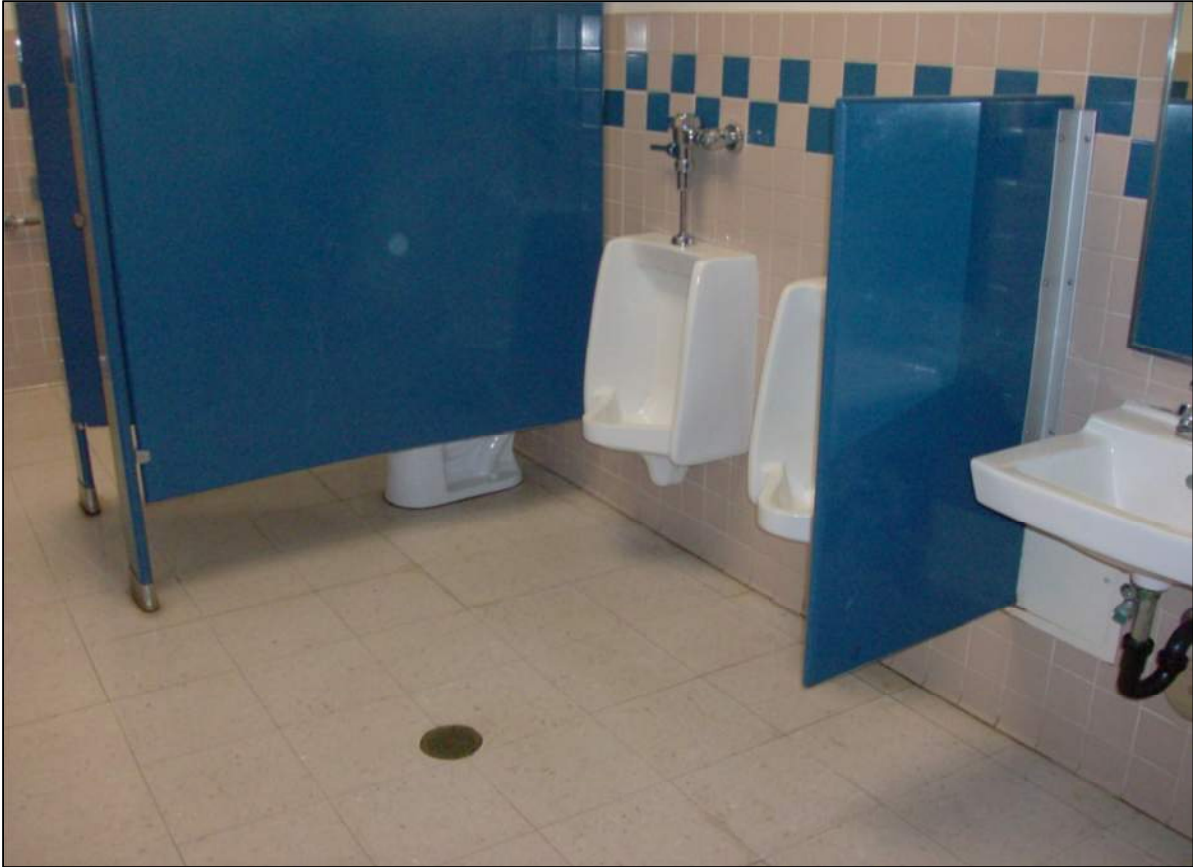
Typical gang bathroom.

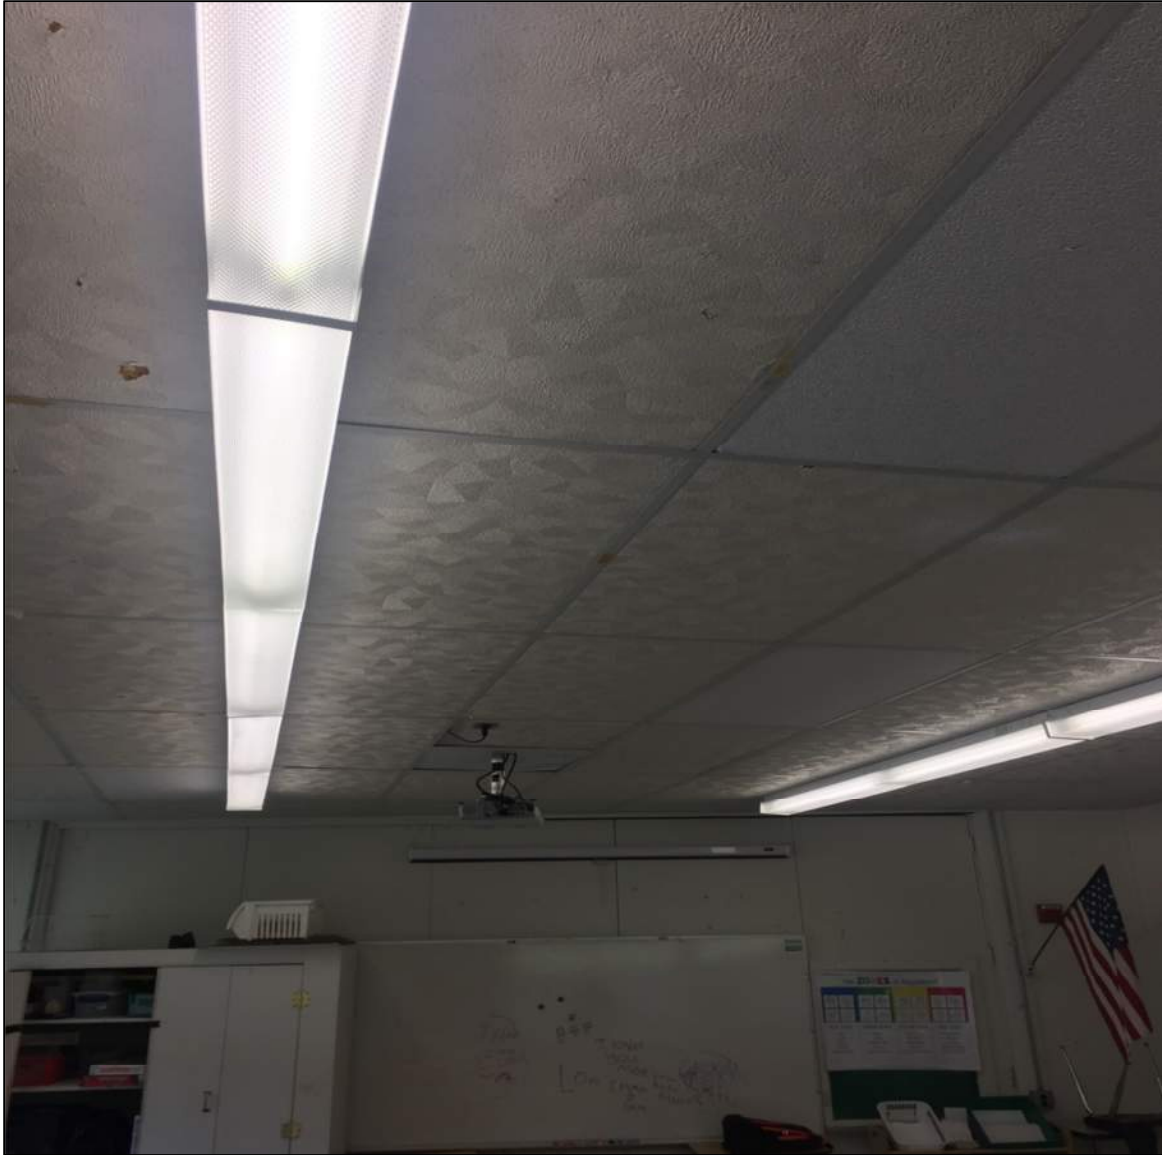
Drop ceilings need to be replaced and upgraded.

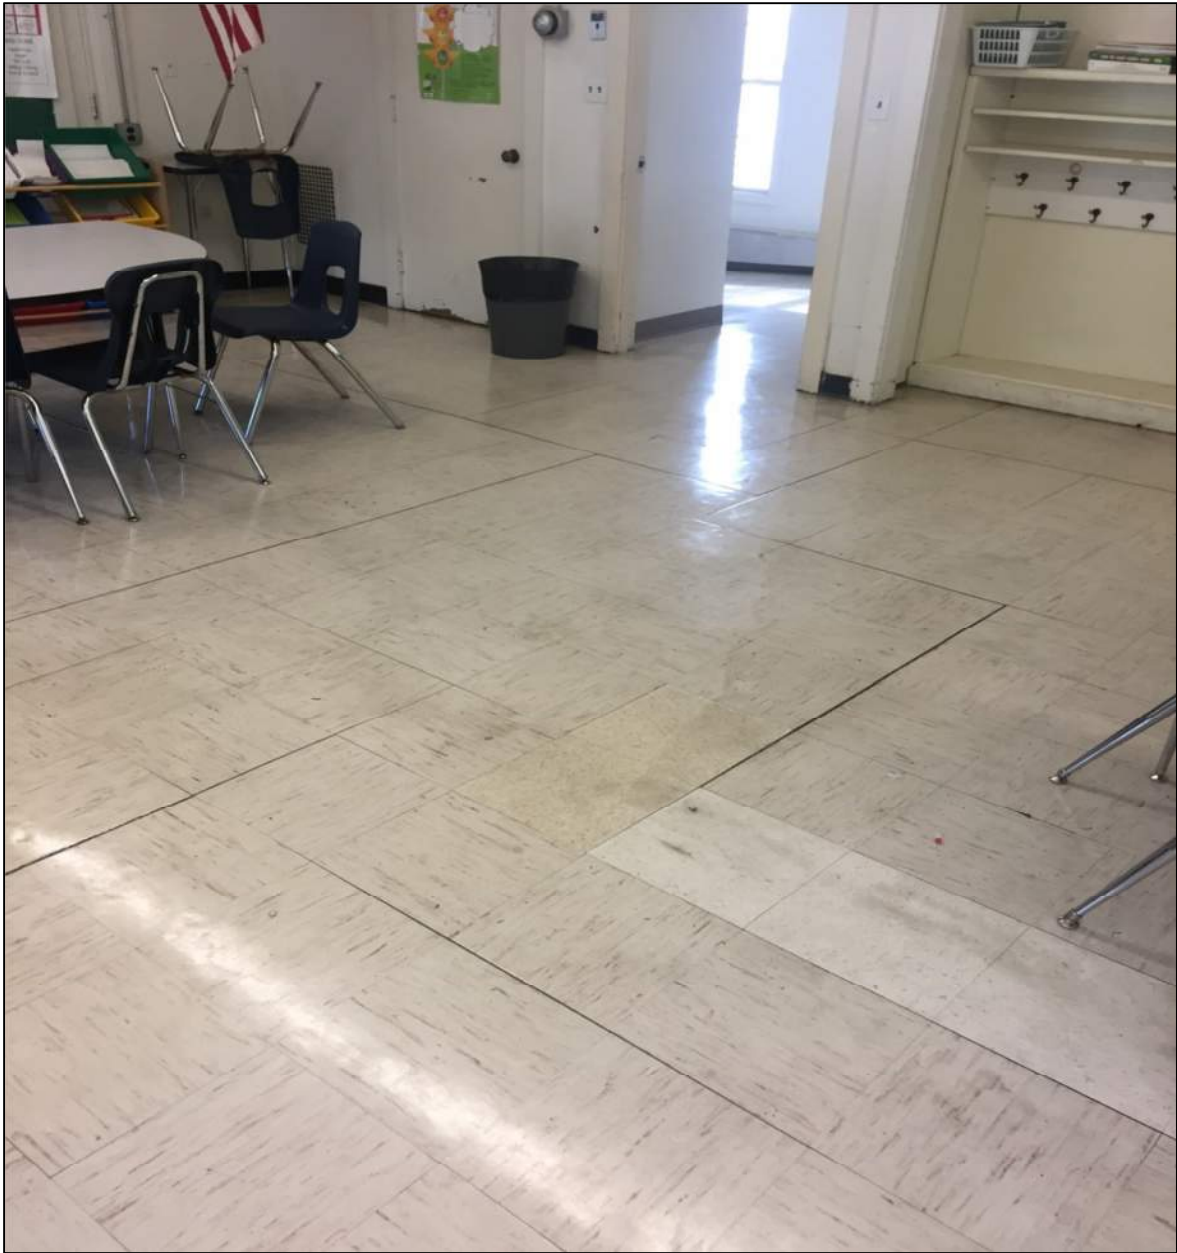
The floors are primarily covered with vinyl composition tile (VCT). The VCT is in fairly good condition throughout the building. One classroom in particular on the south side of the 1999 addition, has large gaps between some of the floor tiles. Other tiles have been replaced within this same classroom indicating an issue with slab movement or slab cracking. This should be further investigated before the floor is replaced. We observed some cracked tiles in the storage room of the multi-purpose room. The tile in the mechanical area of the original wing has seen frequent water, based on heavy staining observed in this area. The staff areas have carpeting, which was in fair condition with typical wear patterns in high traffic areas. The carpeted areas should be replaced in the next five years. The bathrooms in the original wing has ceramic tile which is in good condition other than needing cleaning in some spots.

VCT flooring in 1950's addition. Note gaps in tile and past areas of tile replacement.

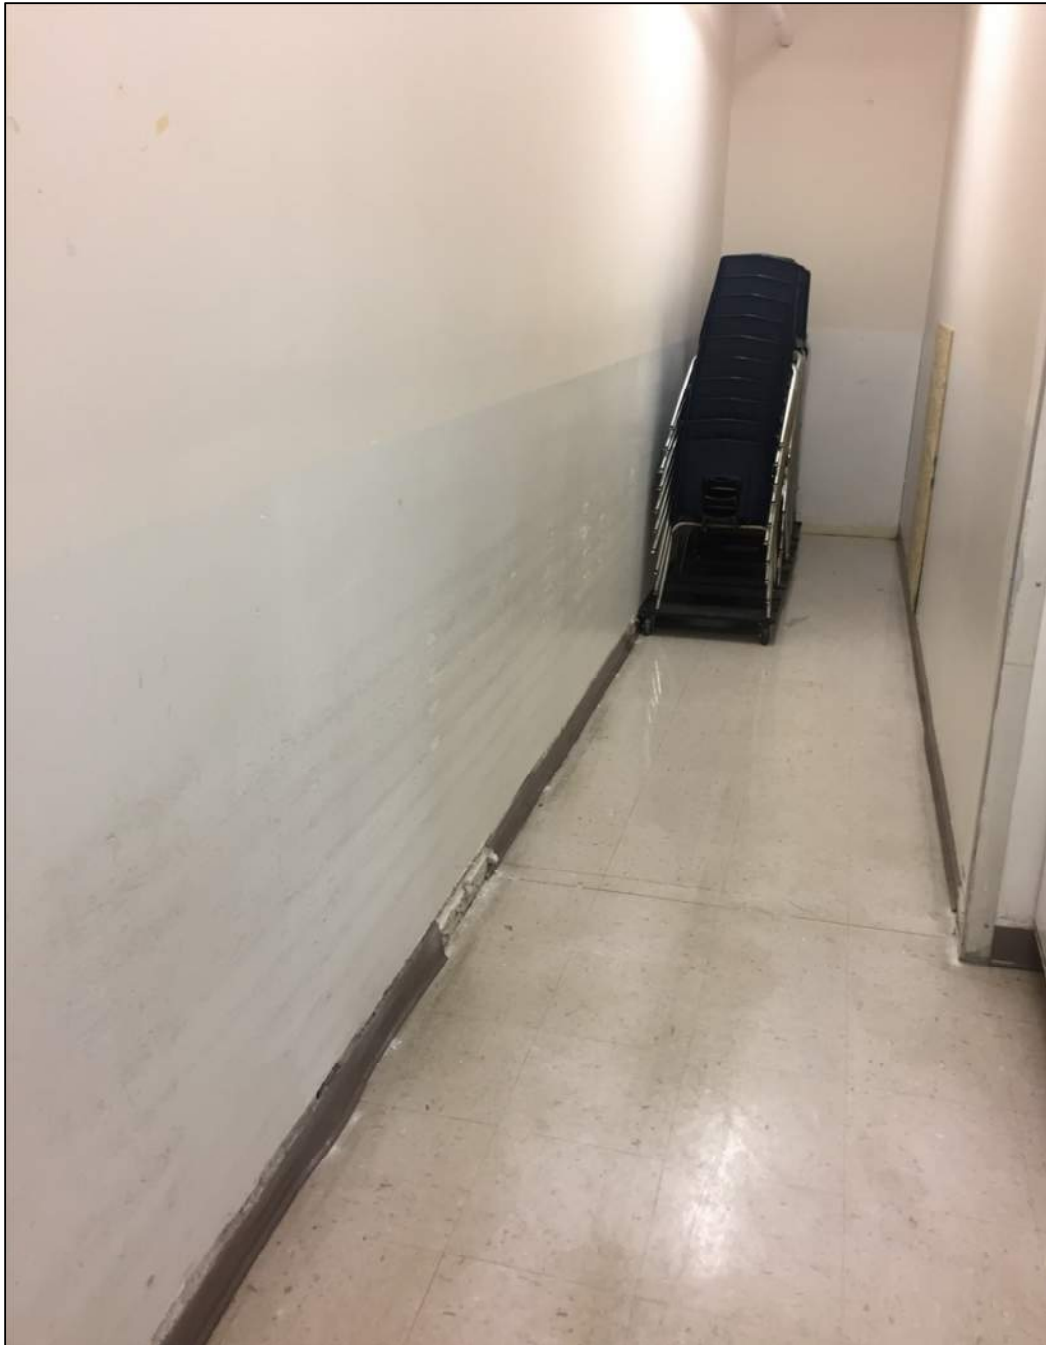
Area adjacent to Gym used for storage of chairs. Note damaged walls and baseboard.

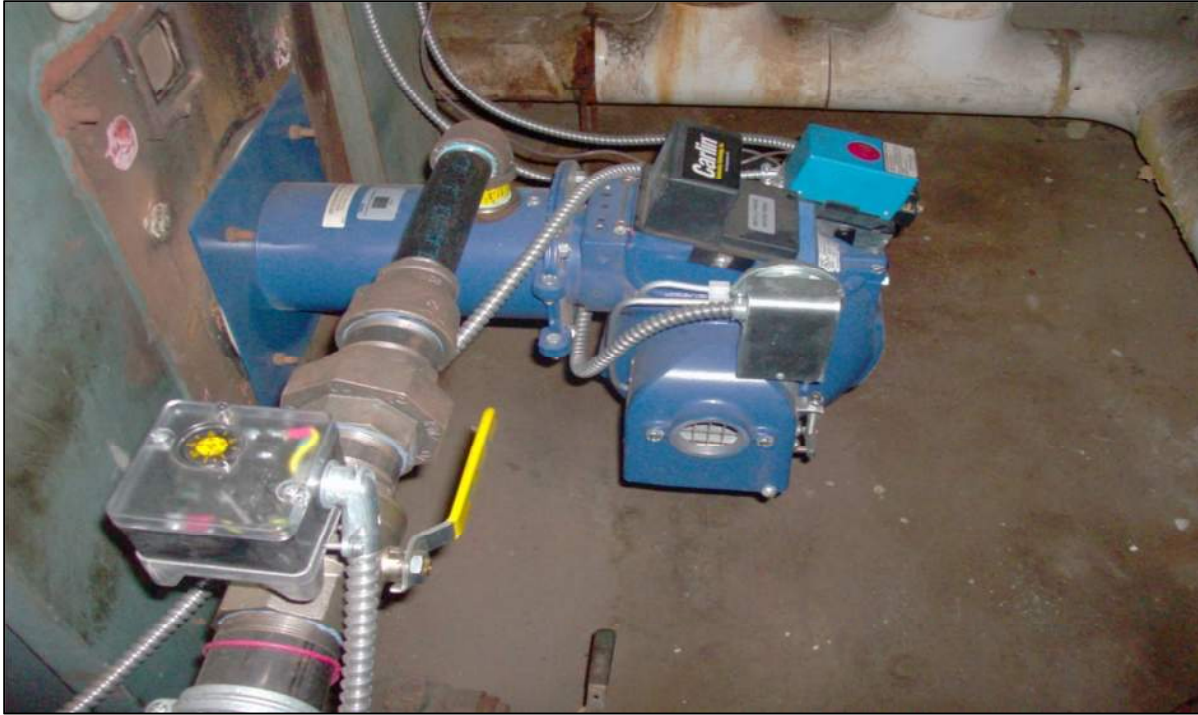
New gas-fired burner on furnace.
