DRAFT REPORT

EVALUATION AND ASSESSMENT EMERSON ELEMENTARY SCHOOLS 27 RHODODENDRON ROAD FITZWILLIAM, NEW HAMPSHIRE

Monadnock School District
Emerson Elementary School
27 Rhododendron Road
Fitzwilliam, New Hampshire

Facility Assessment

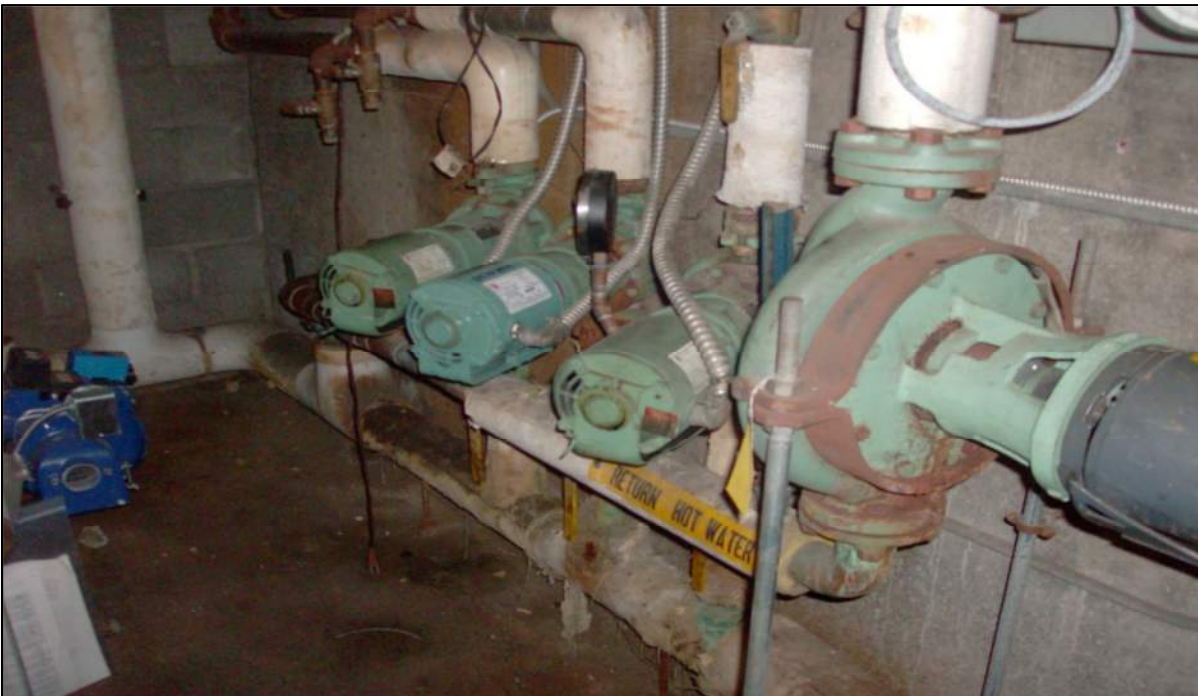
Two of three circulating pumps should be upgraded.

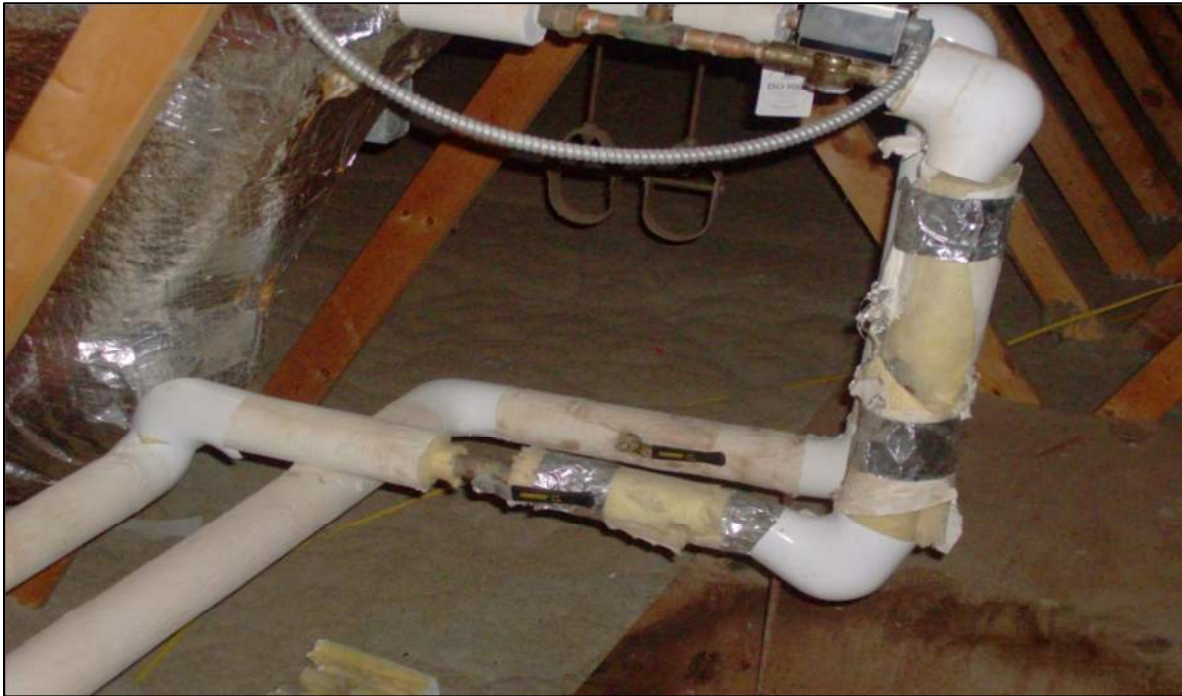
Section of heating piping in attic with no insulation.

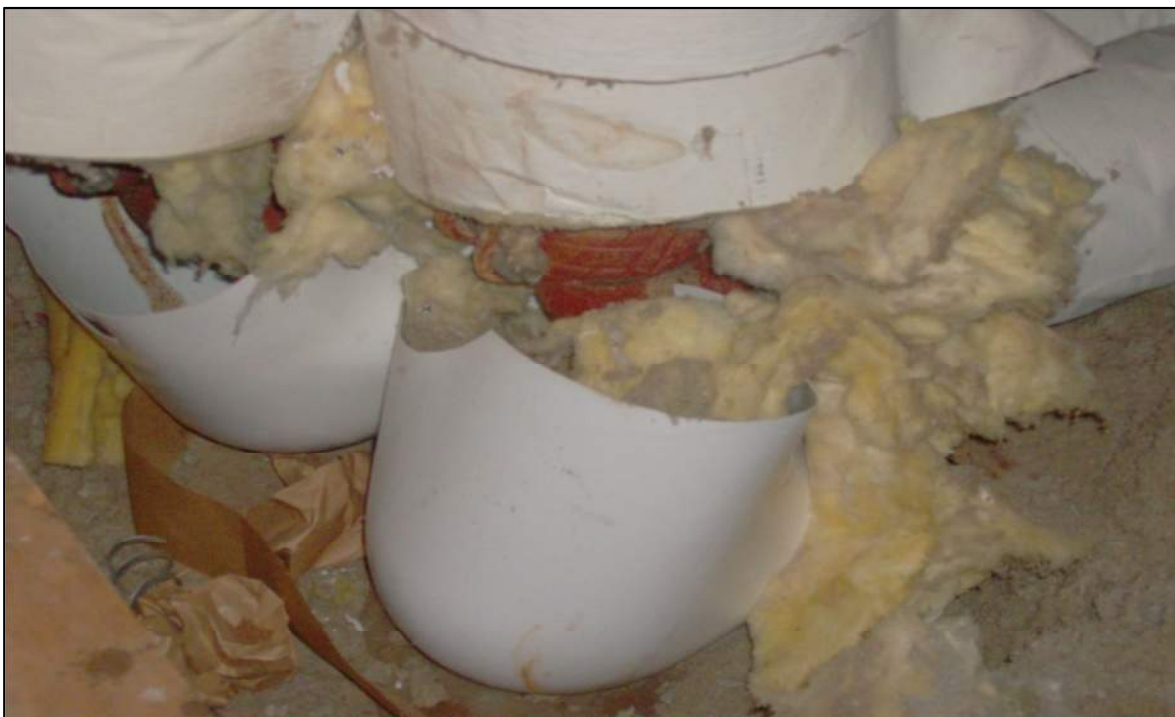
Original pipe insulation removed, but not properly replaced.
