# FINAL REPORT

## EVALUATION AND ASSESSMENT GILSUM ELEMENTARY SCHOOLS 640 NH ROUTE 10 GILSUM, NEW HAMPSHIRE

OCTOBER 20, 2017

### **Facility Assessment**

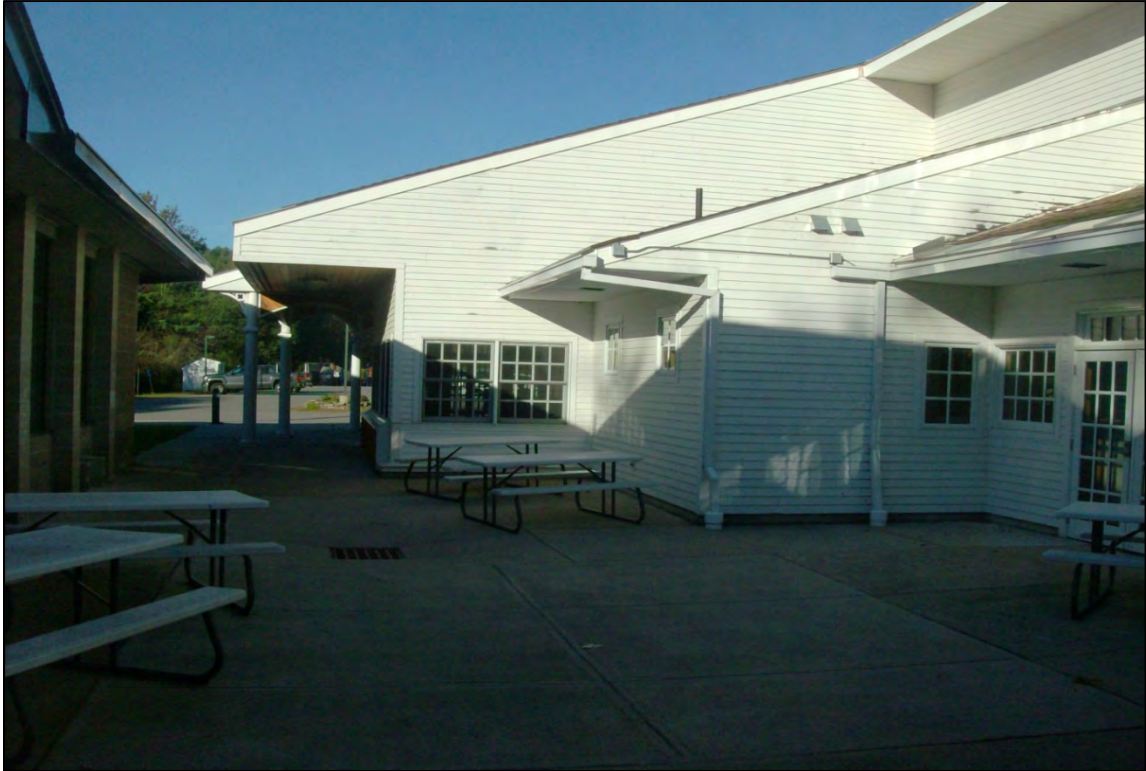
The central courtyard area enclosed by the latest addition and the addition built in the late 1970's are prone to a lot of icing in winter months. Since the roofs all shed towards the courtyard, drainage off the roof was the cause. Gutters were added to alleviate the issue but icing can still be a problem at times. We also noted heat tape was installed along the edge of the courtyard roof and in the gutters to alleviate ice dams and to keep runoff from freezing at the edge of the roof and in the gutters. The area is a constant problem for maintenance trying to keep the area reasonably clear of snow and insure the egress paths are not blocked. But since there is really no place to pile the snow, it must be removed from the courtyard. Lack of insulation or insulation installed in such a manner that it blocks good air flow from the eaves to the ridge may be a contributing factor.

Courtyard area. Note multiple roof slopes directed toward courtyard.

- Reconstruct all interior ramps that do not meet current ADA guidelines (\$20,000 to \$25,000).
- Reconfigure central courtyard to alleviate icing and snow build-up issues (\$200,000 to \$250,000).

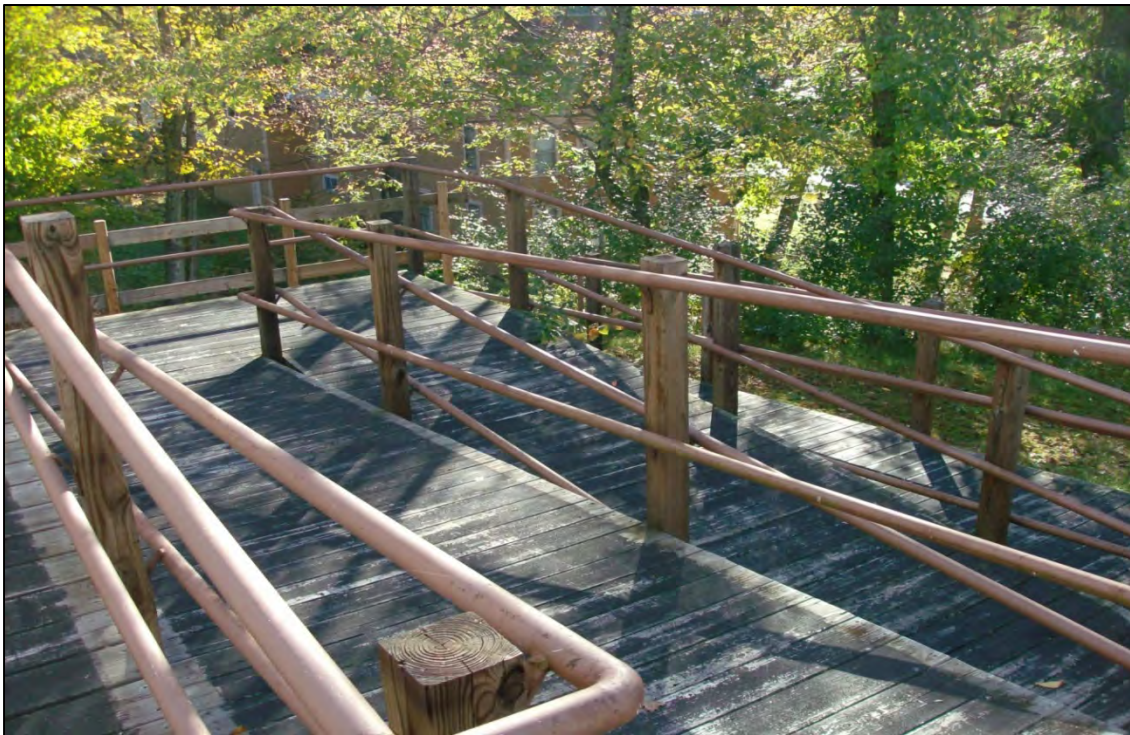
The handicapped ramp exit from the library on the south side of the building is a myriad of back and forth ramps. A better option or layout should be explored. The sill of the door from the library leading to this ramp is in need of new flashing, as water can easily penetrate between the vinyl and the original siding material. The ramp itself needs some wood deck maintenance and railing touch-up paint.

ADA ramp on south side of building with multiple switchbacks.

- Replace all water damaged clapboards and siding (\$1,500).
- Repair door sill at library door that exits to handicap ramp (\$250).
- Replace all damaged boards on the ADA ramp on the south side of the building and renew finishes as required (\$2,000).

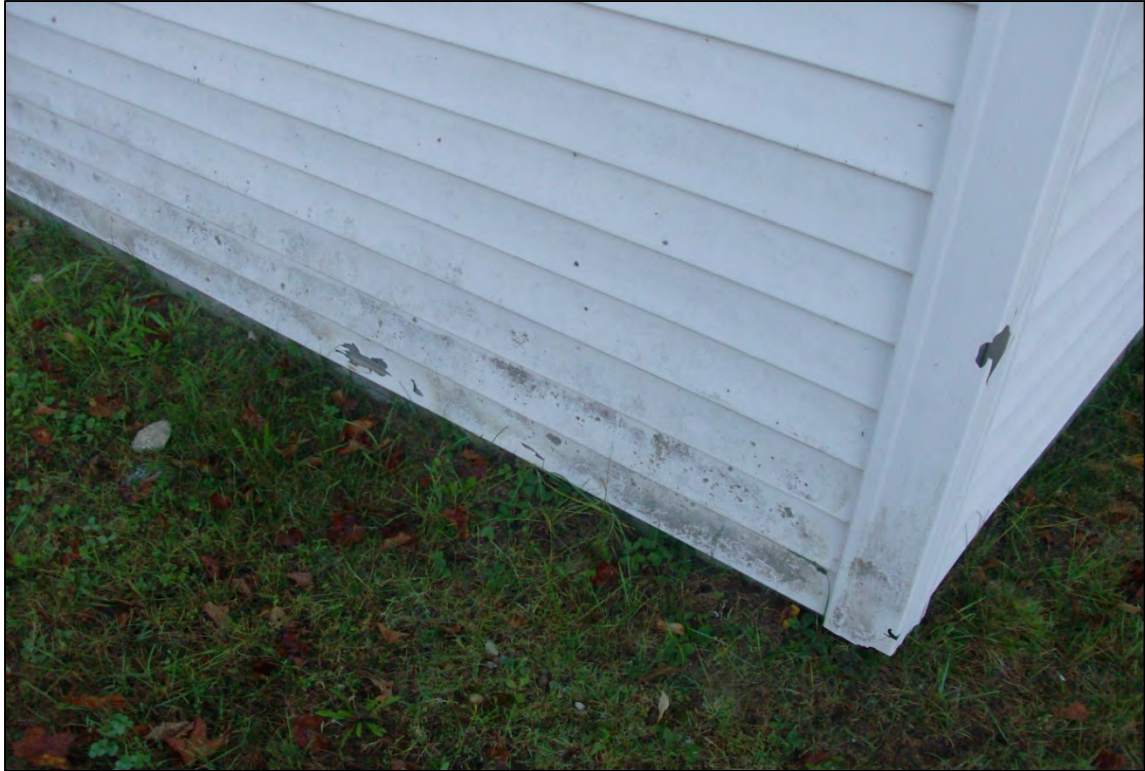
The exterior of the school is sided in a combination of split-rib CMU on the 1970's section, wood clapboards on the 1995 addition, and vinyl clapboards on the 1980's addition and the original building. There is mildew growth on the north and east facing walls and other areas that do not receive adequate sunlight. On the sidewall of the dining room within the courtyard there is an area of water damaged clapboards.

Mold growth on vinyl siding. Damage from “weed whacker”.

- Replace the roof shingles on the entire building (approximately 166 square feet at \$400 per square for materials and labor = \$66,400).
- Clean the siding of mold and mildew (\$1,000).

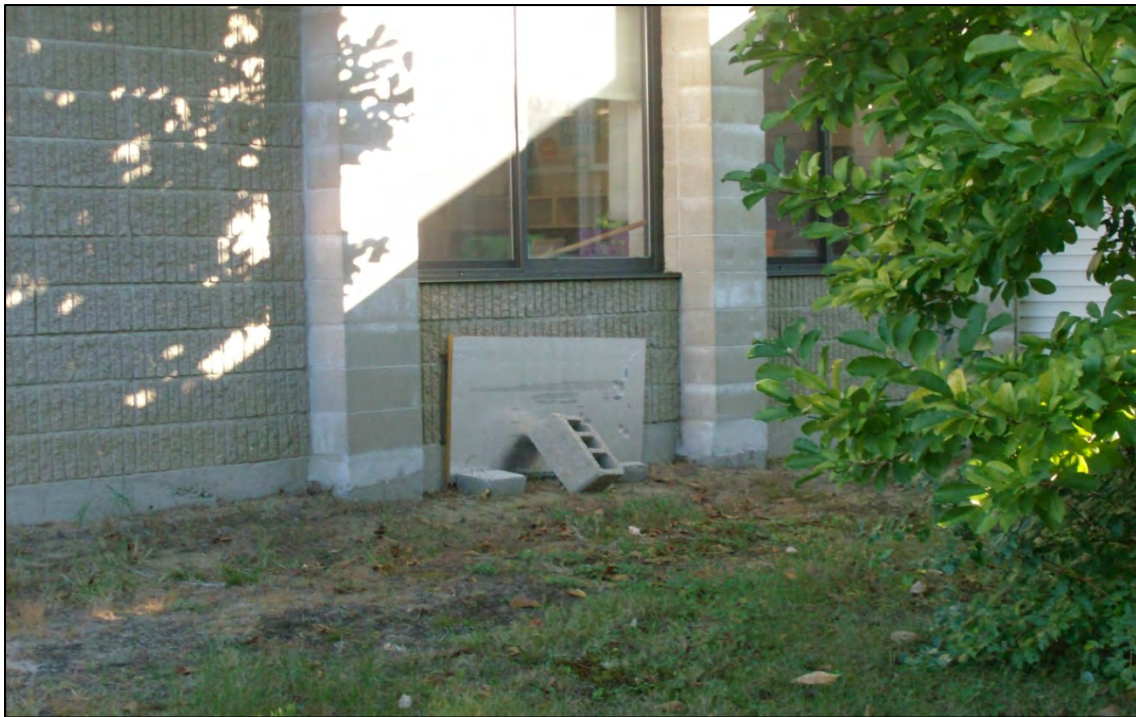
Unit ventilator grille blocked with foam panel.

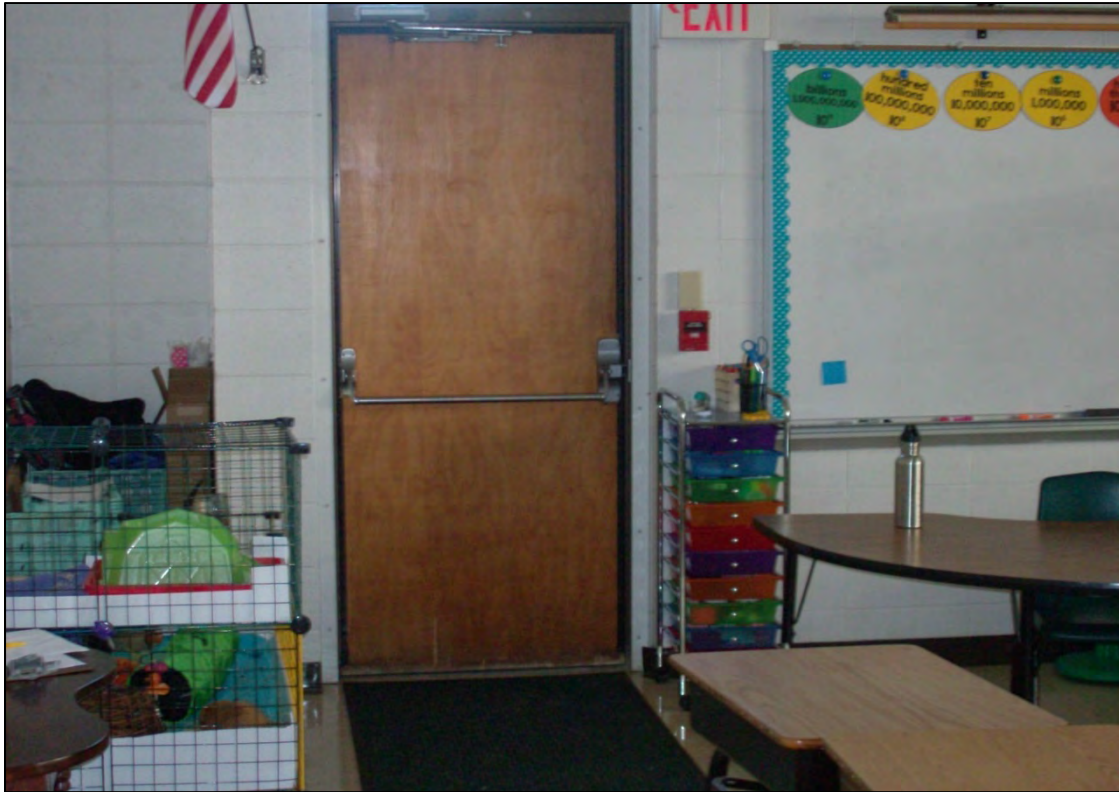
It was reported that the two west facing doors of classrooms 1 and 2, in the 1970's addition, leak quite heavily during a driving rain. Water puddles on the floor inside the door. Apparently some new seals have been installed, but this has not completely solved the problem. This should be further investigated to determine the cause and addressed to

extend the life of the floor and door itself. It may be that the doors may require replacement.

One of two doors that leak during driving rains.

- Install new windows in the 1970's wing which included classrooms 1 and 2, the administration offices, and improve wall insulation (\$30,000).
- Replace doors and frames in rooms 1 and 2 (\$4,000).

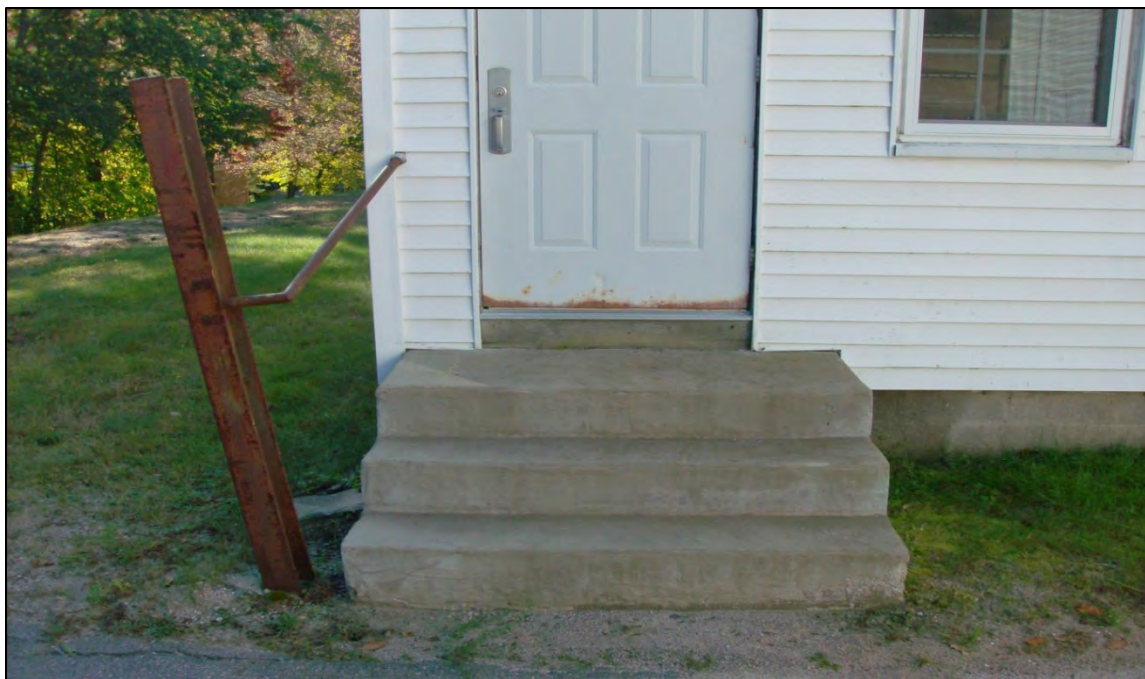
On the north side of the music room (one of the original classrooms) the door is rusted along the bottom and should be repainted. The handrail on the stair is badly rusted and is not constructed per Code. The steel end post had been hit by a vehicle and was out of plane.

Door at Music Room. Door needs painting and railing should be replaced.

- Seal gaps under window sills or install screening so they are insect proof (\$1,200).
- Repaint the rusted door at the music room (\$300).
- Investigate basketball hoop in gymnasium and determine if there are structural issues preventing it from being retracted (\$1,500).

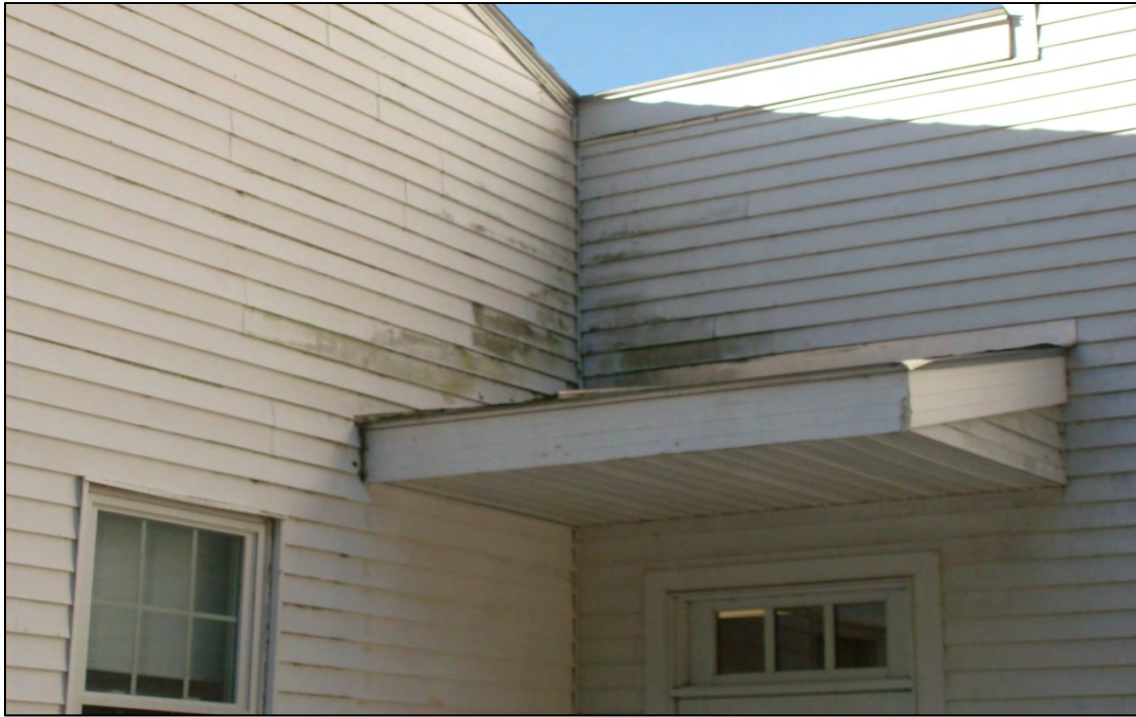
Canopy over door on east side. Note mildew and rotted siding.

- Replace the fire alarm system (\$40,000 to \$50,000).
- Replace railing on exterior stairway at music room (\$3,000 to \$4,000).
- Reconfigure the roof canopy over the door on the east side of the building to improve the shedding of water and install new roofing (\$4,000 to \$5,000).
- Replace all light fixtures with new LED energy efficient fixtures and sensor switches. (\$125,000 to \$150,000).
- Improve air flow in basement area and improve dehumidification of the space (\$15,000 to \$20,000).
- Install school wide air conditioning (\$200,000 to \$250,000).

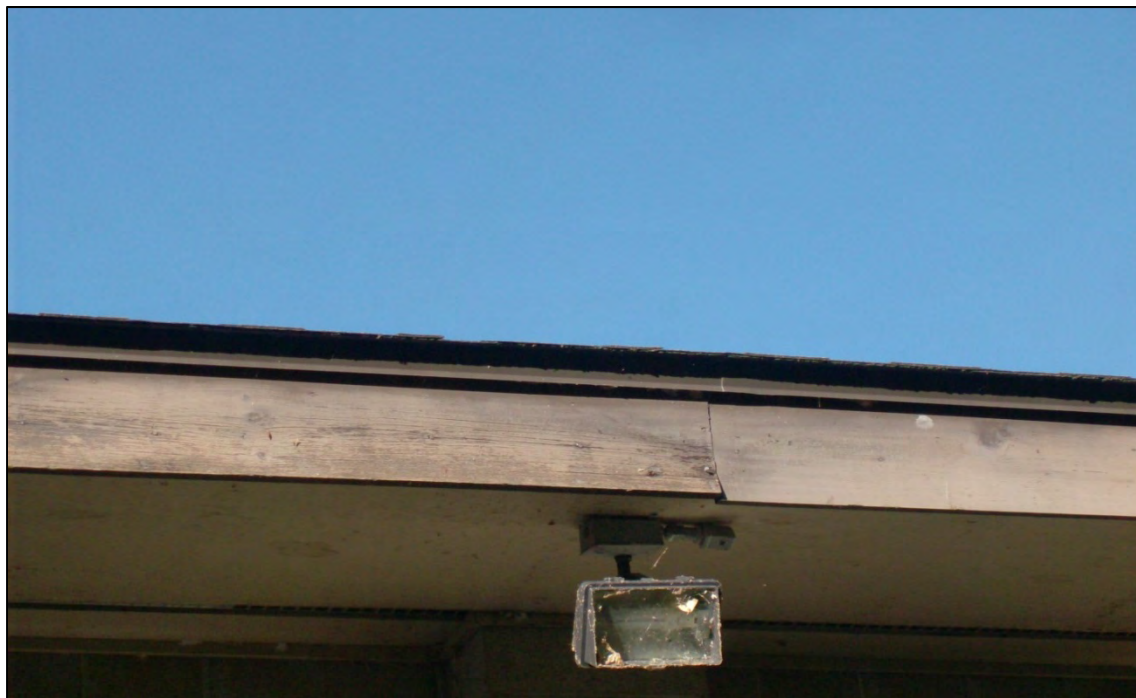
The soffit and fascia trim of the 1970's portion of the building is badly peeling and needs repainting. Some boards are rotted and need replacement. An alternative to repainting is wrapping the trim in break metal. We also observed the fascia trim splice joints around the 1995 addition are separating and need to be covered with a cap piece to seal the joint from water penetration.

Fascia board on 1970's wing needs paint or break metal covering.

- Scrape and paint wood trim on the 1970's wing or wrap the fascia in break metal (\$3,000).
- Exterior of building; general exterior painting (\$5,000).

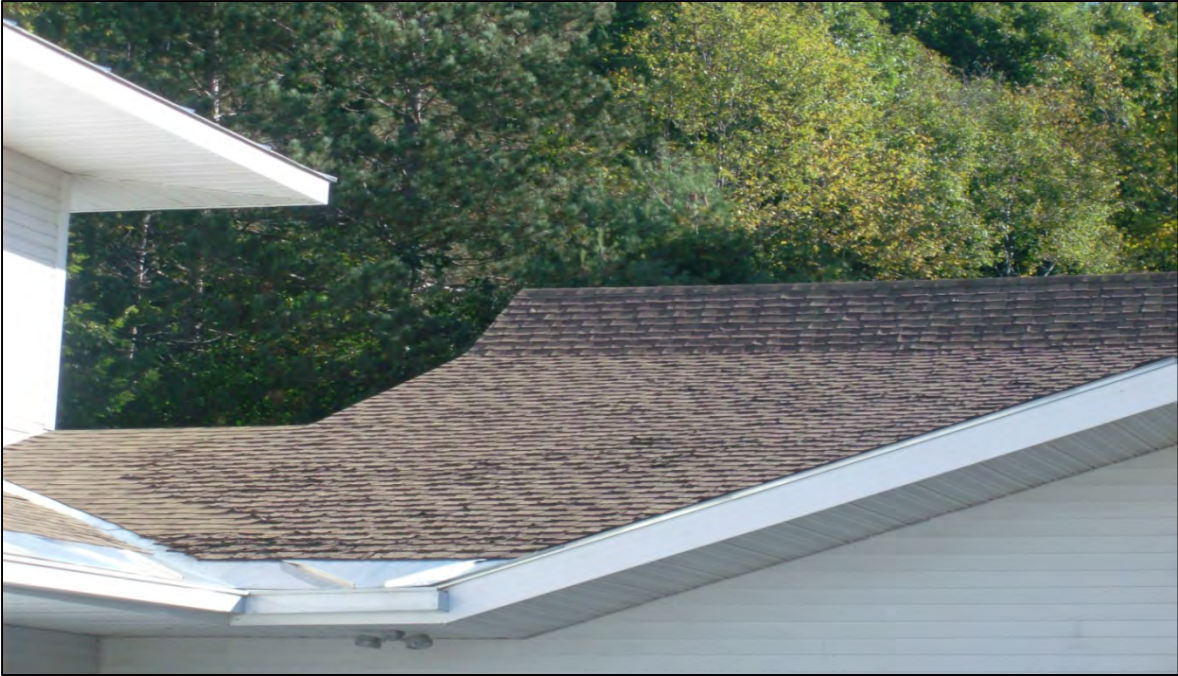
All the roofs are covered with an architectural shingle. As observed from the ground, many of the shingles, particularly on the south and west facing sides, are curling, are in poor condition, and appear to be in need of replacement within the next two to three years. The shingles on the north and east sides did not exhibit this curling, but all the shingles should be replaced at the same time. On the east side of the building adjacent to the music room there is an exit from the corridor of the 1995 wing. There is a small canopy roof over the door and the siding adjacent to this canopy roof had heavy mildew staining and possibly some rot. It is apparent that this canopy roof needs better water/snow shedding capabilities to help prevent this staining and deterioration of the wood.

Poor condition of roof shingles on west side near courtyard.

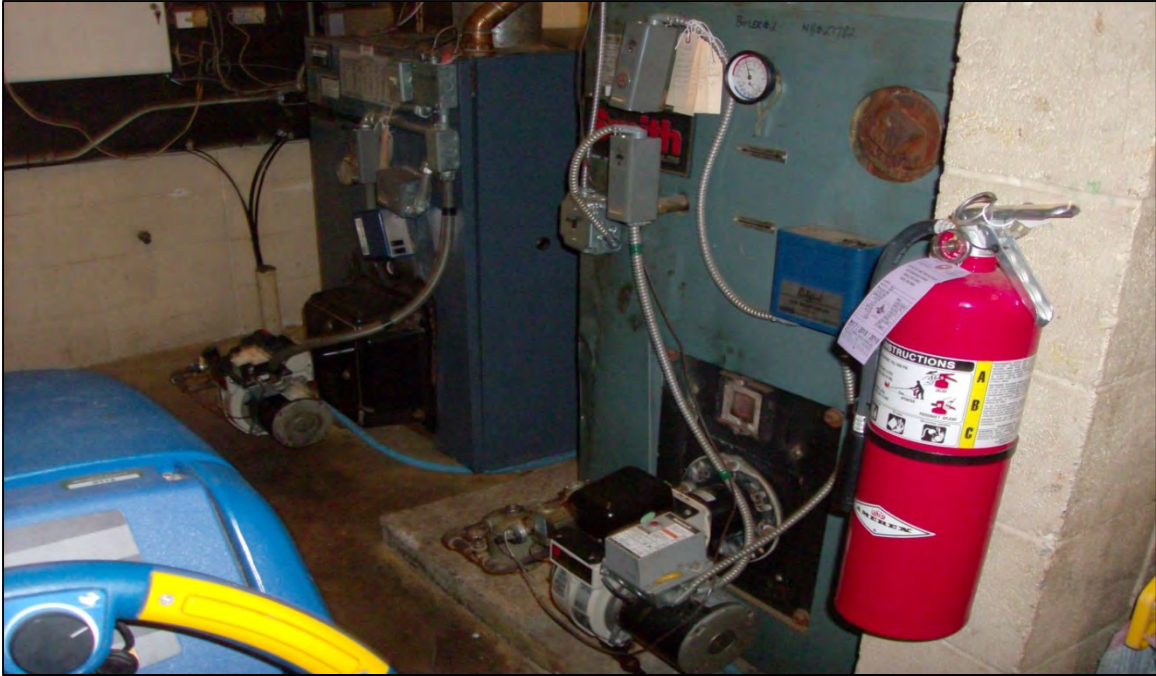
Upon entering the boiler room we noticed the room was excessively overheated. Consideration should be given for exhausting the room. There was some question whether adequate intake air was being provided, as we observed the intake duct was blocked by stacked goods. There are two oil-fired boilers; the newest boiler was part of the late 1990's addition. It is a H.B. Smith Boiler with a rated output of 644,000 BTU's. We recommend the District consider a new boiler plant within the next 10 years. In the future, dual circulating pumps should be considered for redundancy and they should be fitted with variable frequency drives for better control.

Two oil-fired boilers.

- Upgrade the heating system with a new boiler plant and revise the heating system to include a dual pump system with a variable speed drive for more efficient operation, and a back-up in case of pump failure (\$140,000 to \$160,000).

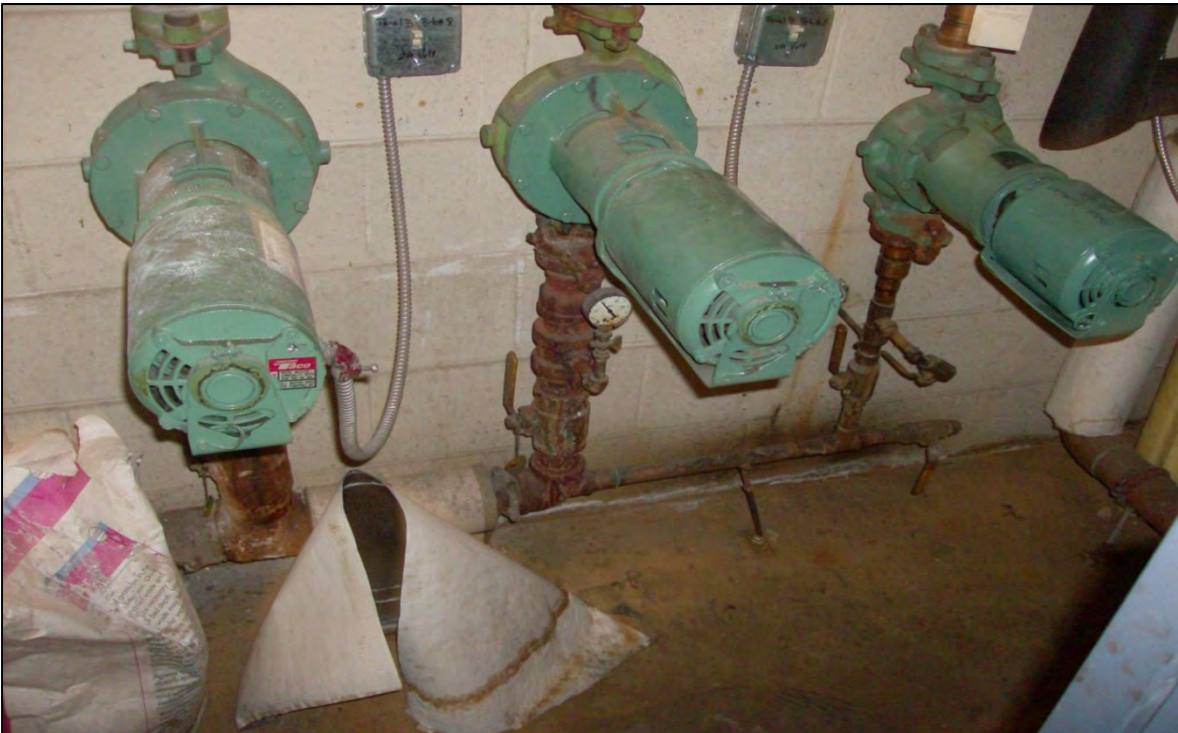
Hot water circulating pumps.
