EVALUATION AND ASSESSMENT

MONADNOCK REGIONAL MIDDLE/HIGH SCHOOL
580 OLD HOMESTEAD HIGHWAY
SWANZEY, NEW HAMPSHIRE

The H.L. Turner Group Inc.

Facility Assessment

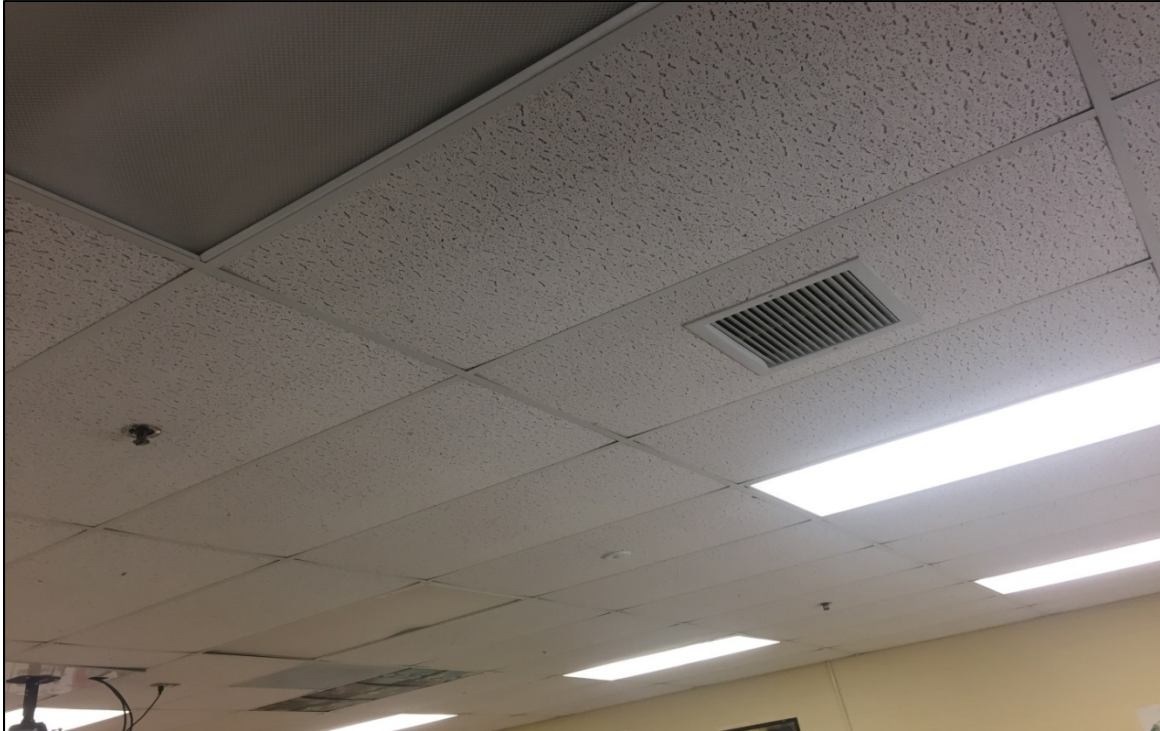
The ceilings throughout most of the educational areas are acoustical ceiling tile. The tiles are fine fissured panels. The tiles are in fair condition with some staining. Most of the tiles are cupped or distorted, indicating excessive humidity issues. In general, the ceiling tile should be replaced in the next four to five years.

Suspended ceilings are cupped and stained.

- Replace all existing lighting in the 700/800 wings with LED pendant type lighting fixtures..... \$75,000 to \$85,000
- Replace all drop ceiling tiles in the 700 and 800 wings \$15,000 to \$20,000

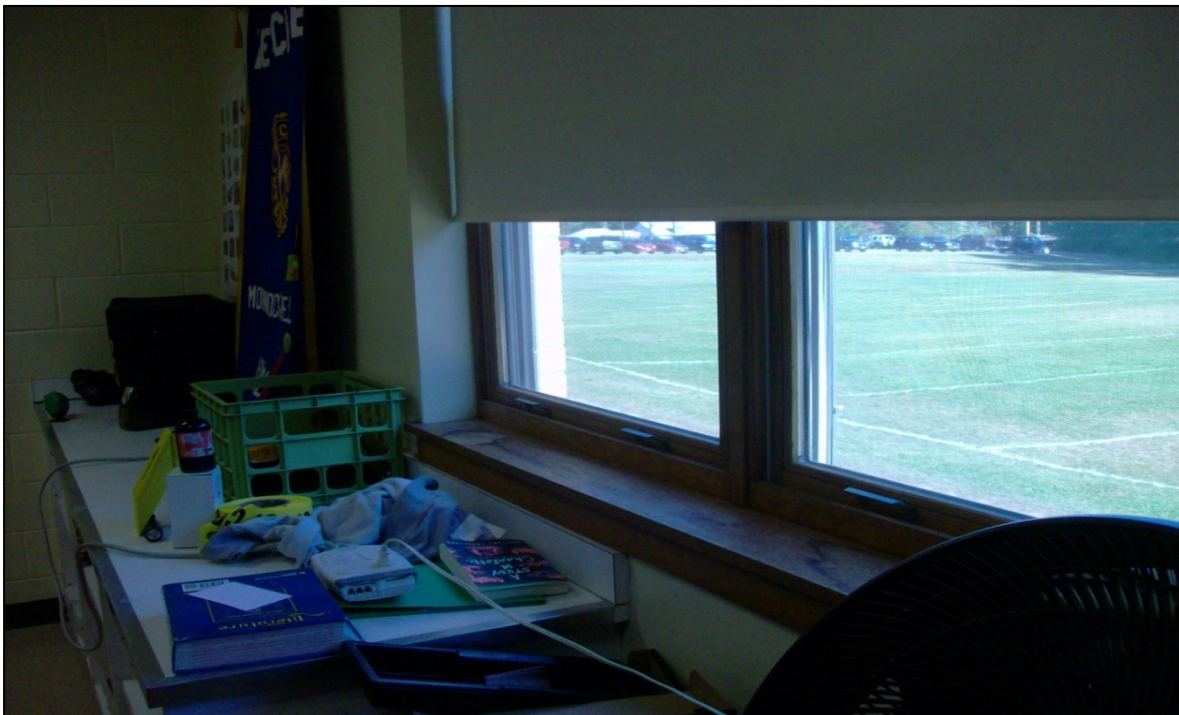
Most of the windows in the 700 and 800 wings are double-hung windows. Most of the windows are over 20 years old and some are even beyond that. The windows are leaky in terms of air infiltration and some of the seals are starting to deteriorate. All the windows in these wings should be scheduled for replacement in the next two to three years. In some rooms the windows are set in a full height masonry veneer wall, while in other rooms the windows are set in the masonry veneer wall that extends to the top of the window, and has an insulated metal band above it up to the roof line. In each case, new windows of a similar size should be installed.

Wood framed, double-hung windows are nearing the end of their useful life.

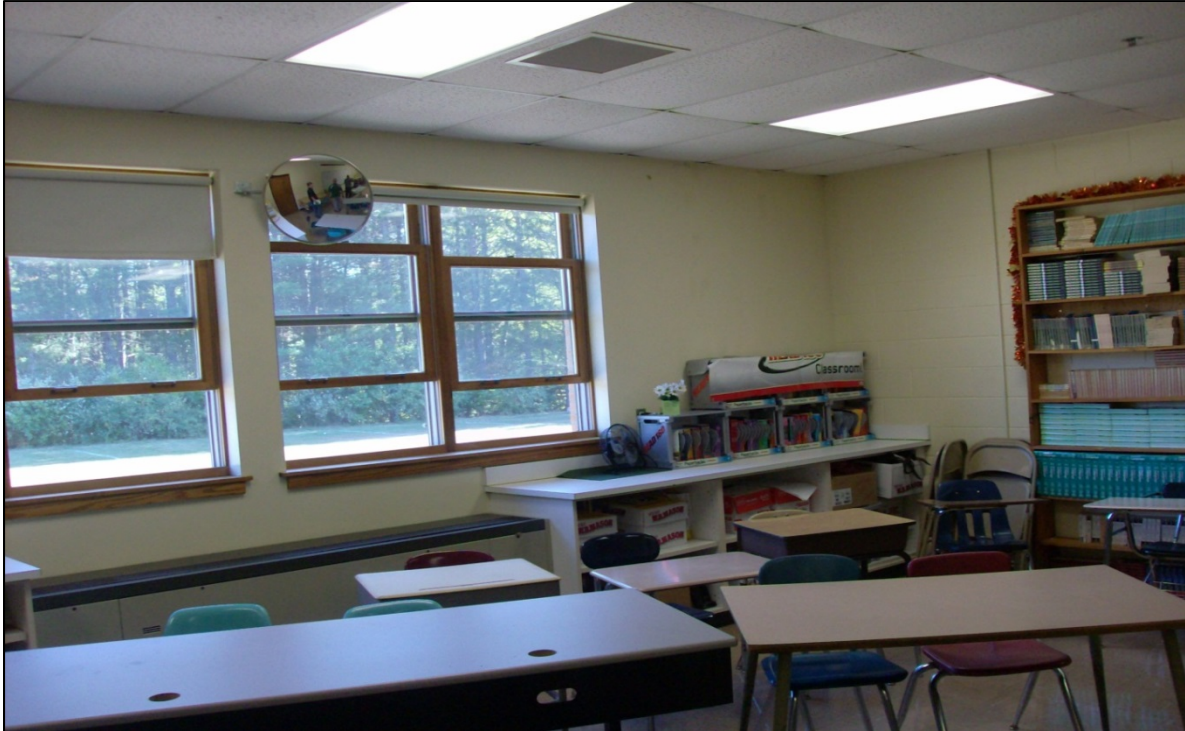
Heating of the classrooms is through unit ventilators mounted on the exterior wall below the windows or in some cases hung from the ceiling just above the windows. These units are beyond their useful life and should be replaced with an alternate heating source such as radiant ceiling panels as was done in a previous upgrade.

Ceilings, windows, and unit ventilators all need replacement.

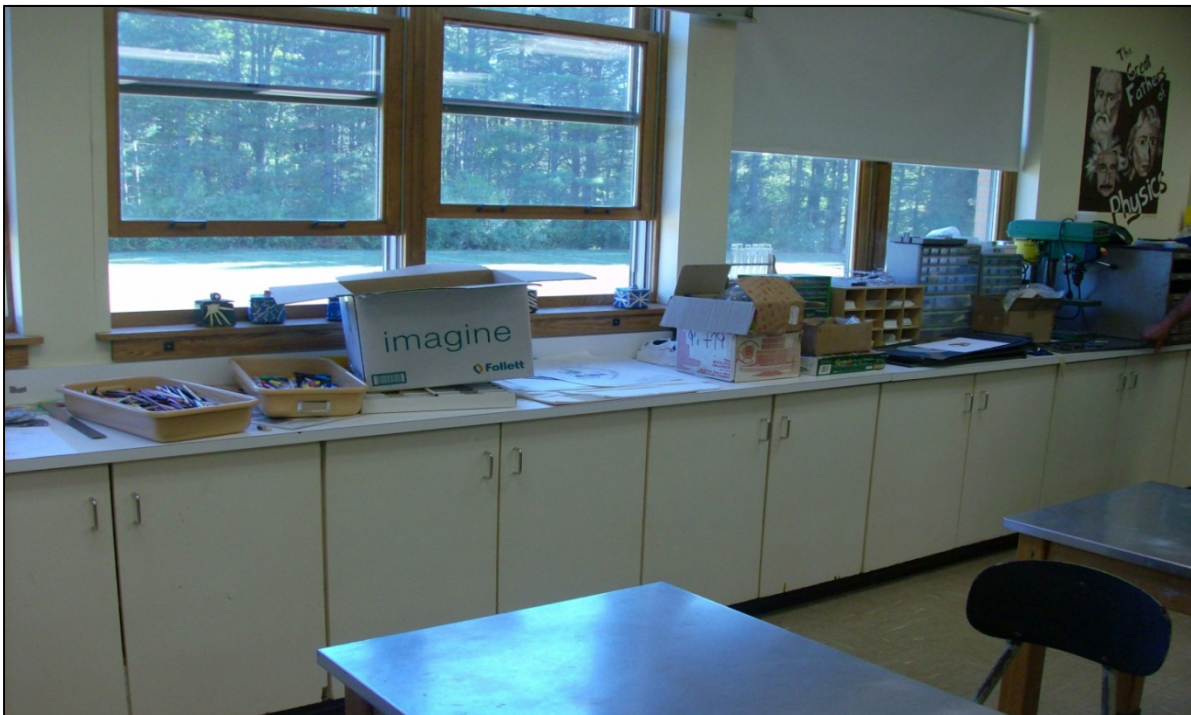
Many of the classrooms have built-in casework along the walls below the windows. Much of this is in poor condition and needs to be replaced. Rather than replace this casework in kind, it is recommended that any new casework be mobile and not fixed in place. A former chemistry laboratory now serves as an art room. Along the corridor and interior partition wall, there are long counters with epoxy resin tops, built-in sinks, and pull-out drawers below the countertop. These units should be left in place; however, the existing gas valves on the countertops should be removed and the gas line removed and properly capped. The gooseneck faucets with serrated nozzles, currently at each sink, should be replaced with a conventional faucet. In the corner of the room there is an eye wash station which is no longer needed for the art room and it should be removed.

Permanent casework should be removed and substituted with portable storage units.

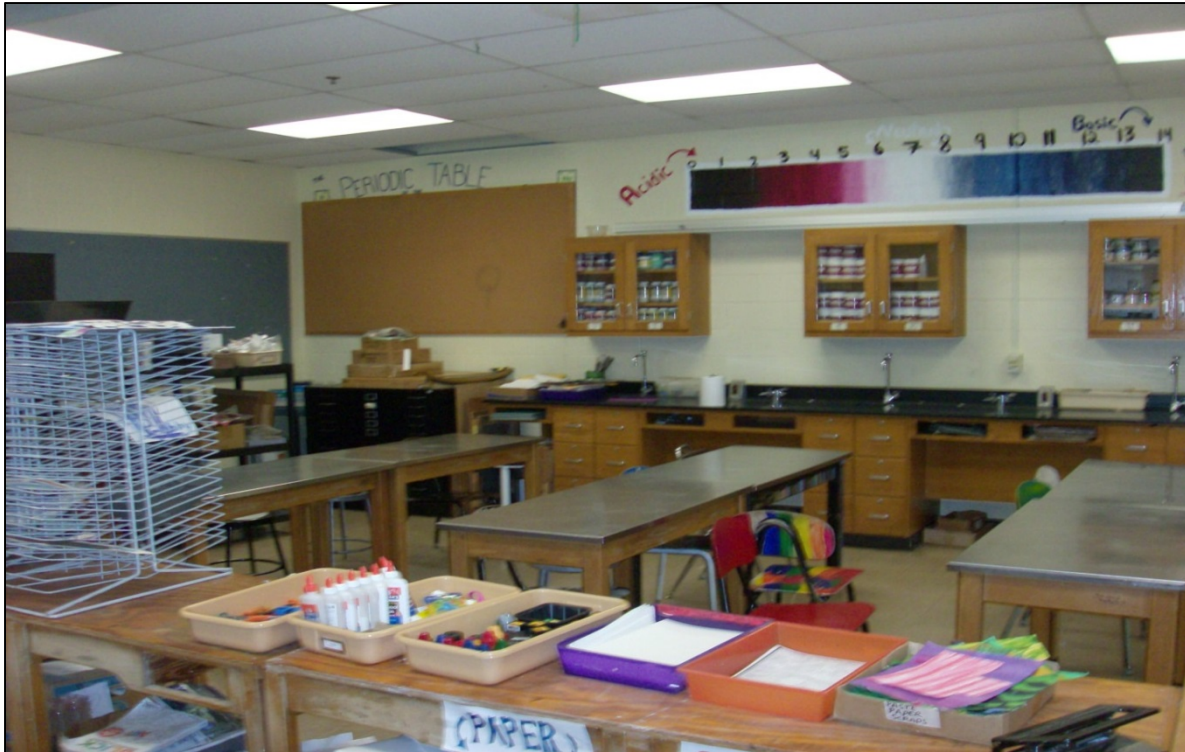
Former chemistry work stations along wall should remain for art class.

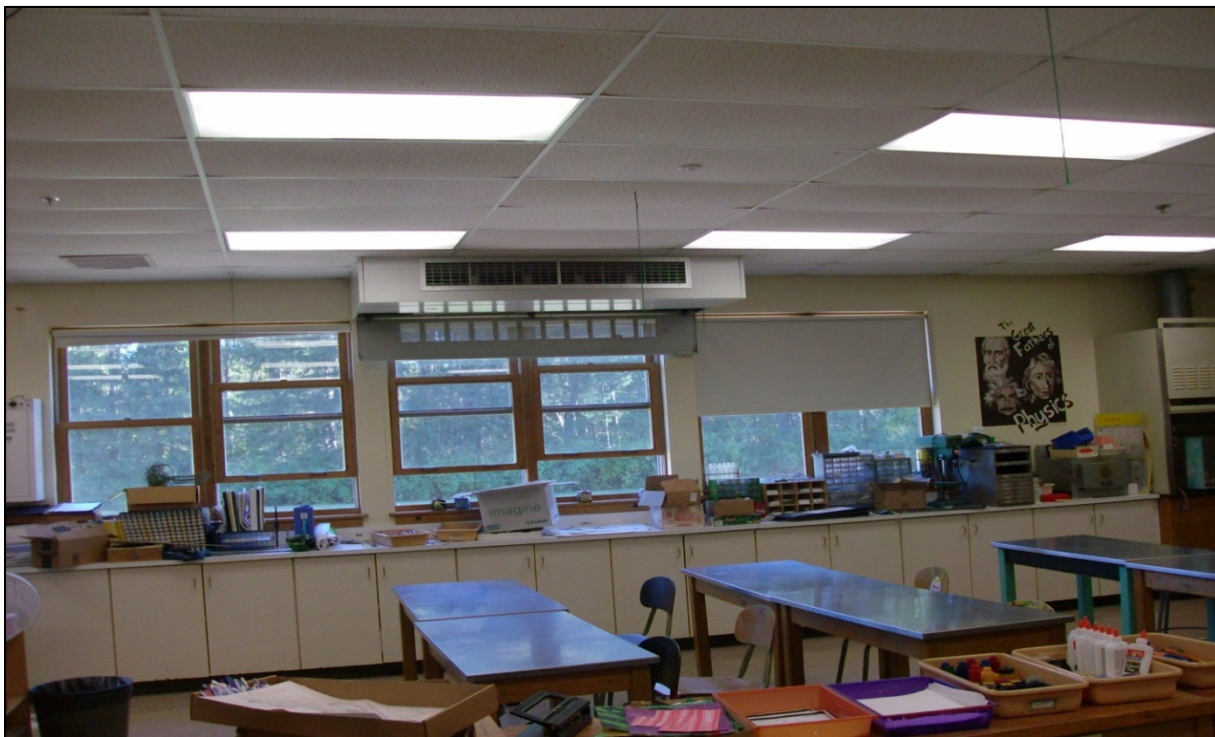
Ceiling mounted unit should be replaced.

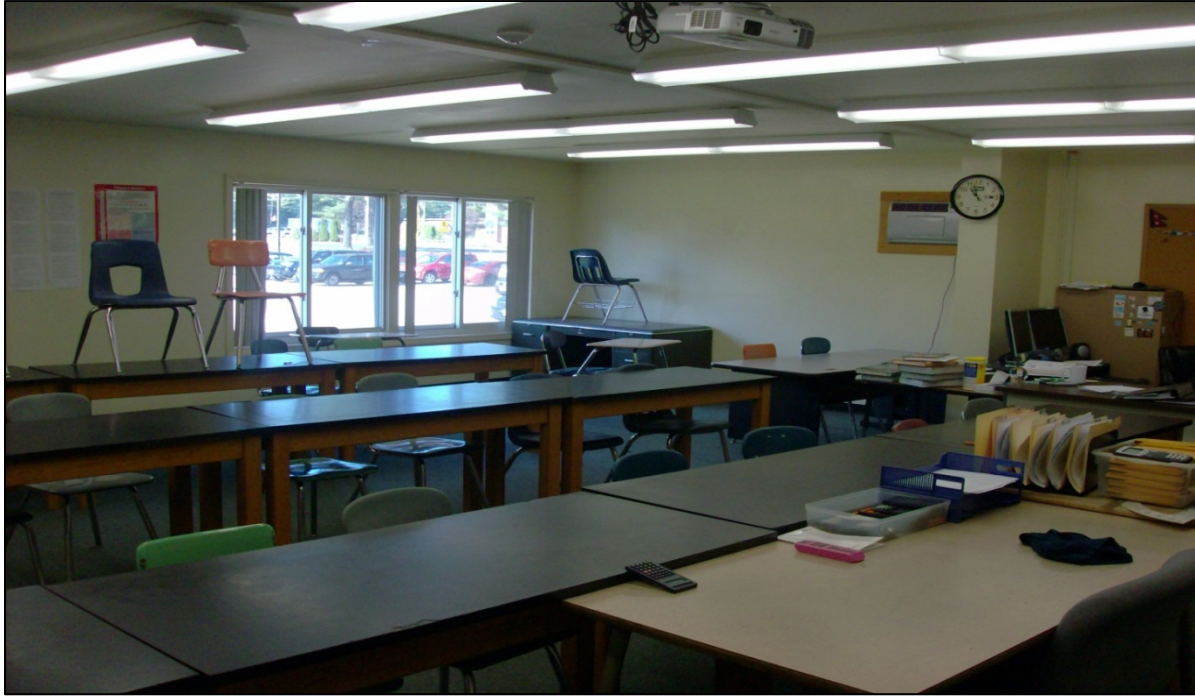
Rooms 707, 708, 709 and 710 as mentioned earlier, appear to have been added as a temporary measure to provide additional classroom space. The temporary nature of these classrooms has led to premature deterioration and failure of windows, roofing, and most of the finishes. Rather than invest in trying to refurbish this temporary space, the overall recommendation is to remove these classrooms from the school. New classroom space to replace these rooms can be provided in the existing courtyard area between the 600 and 800 wings. The courtyard can be in-filled to provide the needed classroom space similar to what was done for the Discovery Center.

Room 709 part of portable/temporary add-on classroom.

- Build new classroom space in the existing courtyard between the 800 wing and the 600 wing, and demolish the temporary classrooms (rooms 707 through 710).

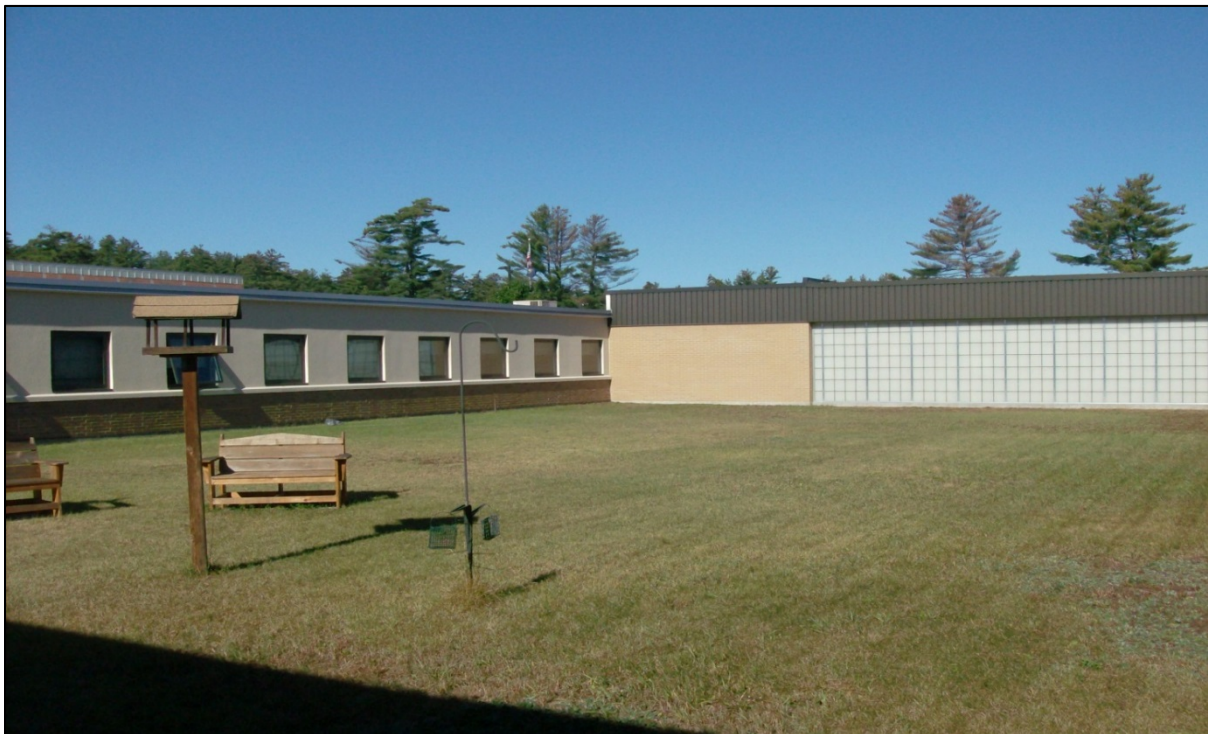
Existing courtyard could be enclosed for new classrooms.
