MONADNOCK REGIONAL SCHOOL DISTRICT

FACILITY AND SPACE NEEDS ASSESSMENT STUDY

OCTOBER 31, 2019

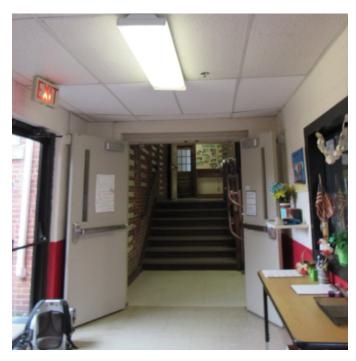
View of front lobby looking upstairs to principal's office. The lobby is open to the corridors of later wings and not fire rated nor secure.

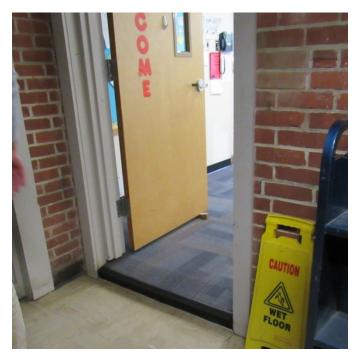
Entrance to a special needs classroom that is not handicap accessible.

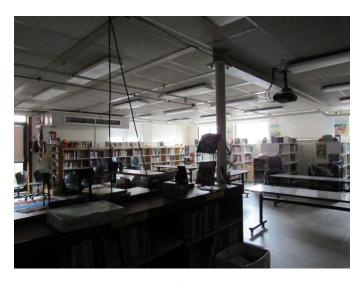
View of Library.

Note the column in the center of the room and the emergency exit to the outside towards the left.

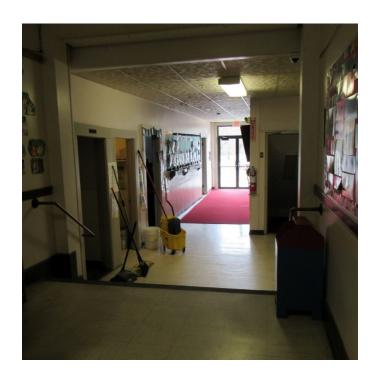
View of corridor leading to original front entrance.

Note the steps in the foreground making this part of the building not handicap accessible. Also note the stairs on the right to the basement.

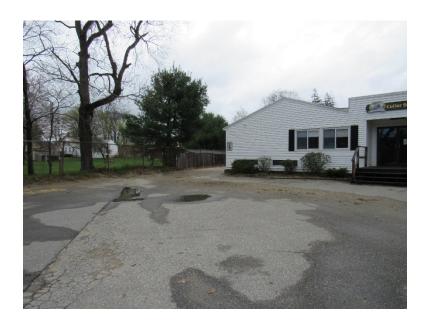
View of narrow alley that busses must pass through.

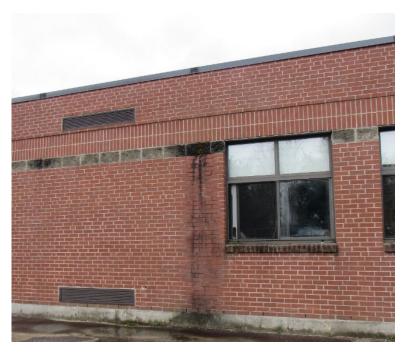
The exterior has numerous needs. The fire escape stairs do not meet code for exit discharge. The last addition has a significant amount of mold on the split-faced concrete block. This is caused by moisture. The source of this should be investigated and the mold cleaned. Many of the windows need replacement.

Exterior with mold from past moisture problems.

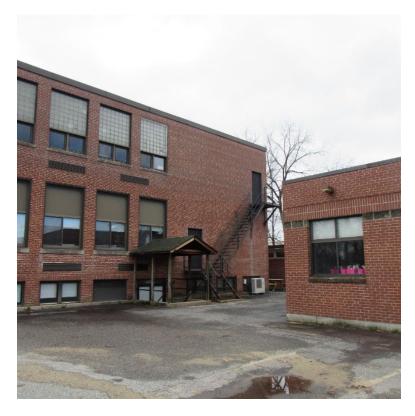
View of the rear of the 3-story structure.

Note the fire escape that does not meet code.

Note also the courtyard between the building wings that extends to the front lobby.

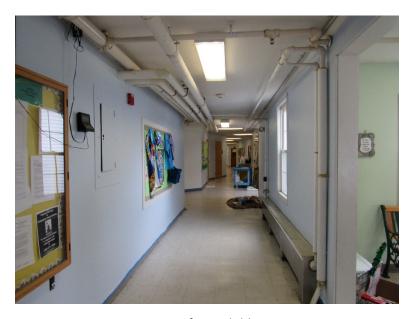
View of main lobby.

Note the exposed heating pipes.

The entrance to the main office is to the right.

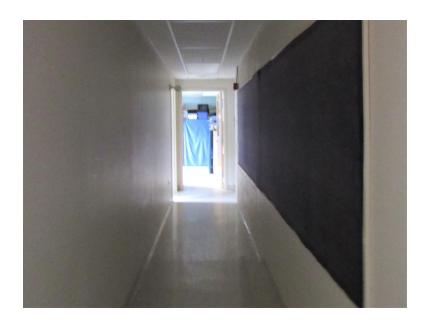
Basement corridor that is too narrow for code.

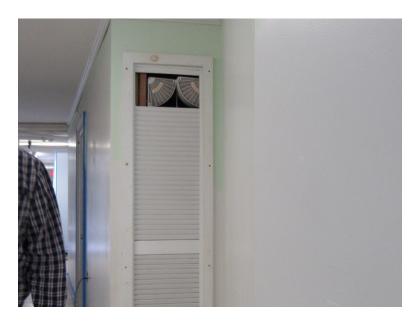
An unprotected vent into the corridor.

Note the residential fans.

Corridors need to resist the passage of smoke.

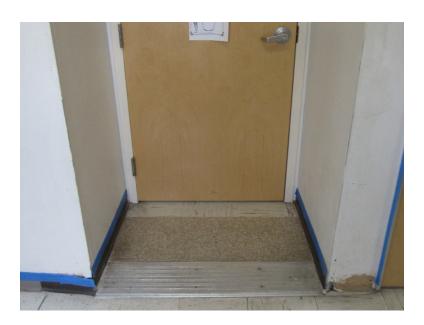
A classroom doorway that is not handicap accessible due to lack of pull-side clearance.

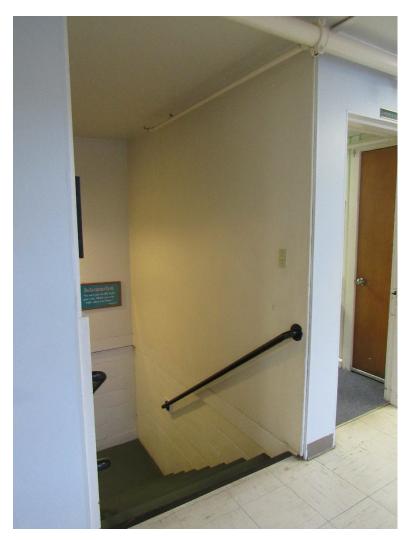
View of unprotected stair to basement.

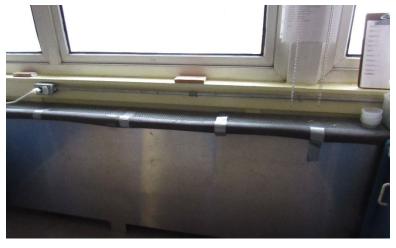
Archaic fin-tube heating element with foam duct-taped to it for protection.

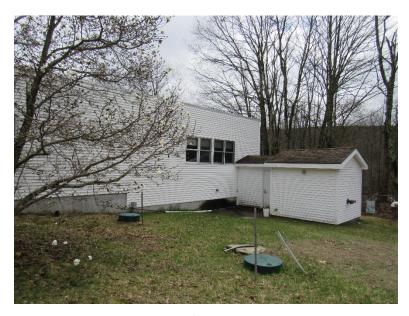
Exterior of kindergarten.

Note the steep grades making a second exit difficult.

Also, note the buried tanks.

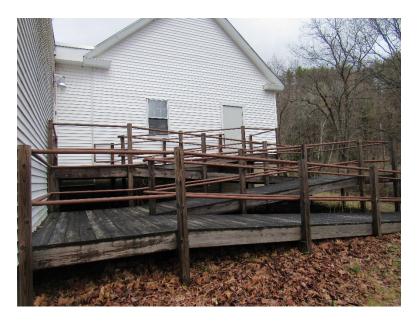
View of extensive network of ramps used as an exit discharge.

Note the lack of guardrails from the higher levels.

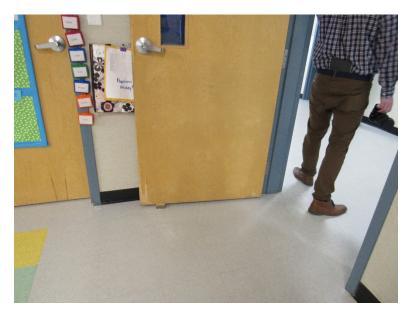
This school is mostly upgraded but some areas still show signs of wear such as this door that has been damaged by a door chock.

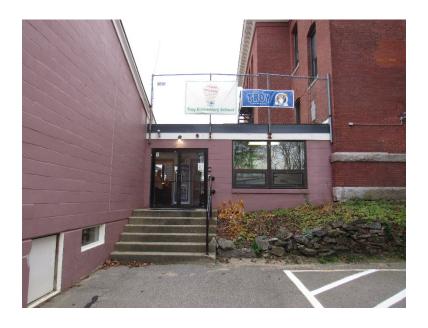
Front Entrance.

Note the fencing on the roof to prevent unauthorized access.

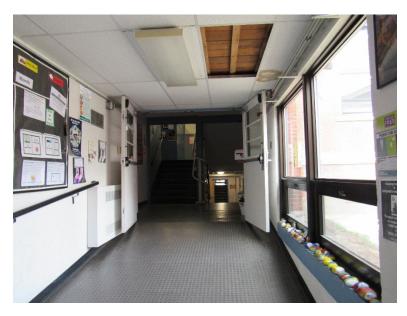
View from lobby to stairs.

Note that the fire doors open onto the ramp.

Also note the stair lift attached to the railing impeding with the railing use.

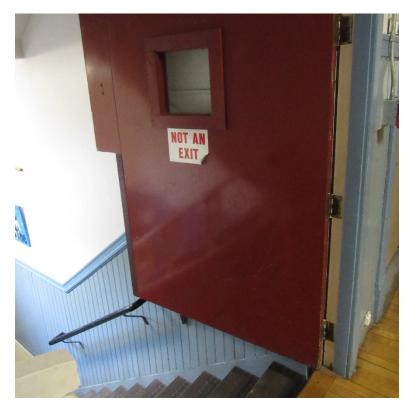
Doors at the top of the stair open over the stairs and have been notched to clear the stair lift making them not fire rated.
